XF1F1 LOW HARDNESS

Action Plan

• **Supplier:** Endurance Technologies Ltd.

• Parts name: Front Fork

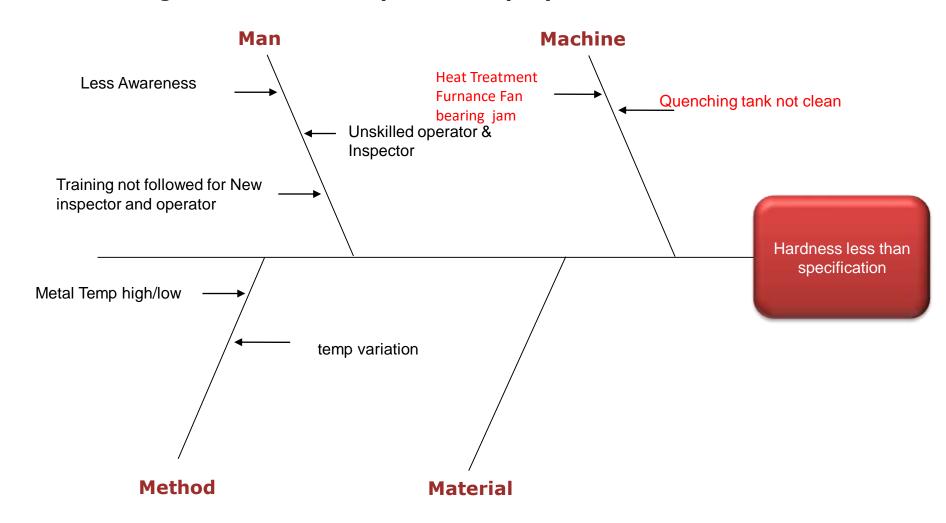
Understanding the actual cause – (Factor analysis)

| SR NO | 4M | PROBABLE CAUSES | FACTS VERIFICATION | Judgment |
| 2 | MACHINE | Fan bearing not ok Quenching tank not clean | Heat Treatment Furnance Fan bearing jam & Also Monthly cleaning tank frequency. | X |

| | WHY – 1 | WHY- 2 | WHY -3 | WHY-4 | Why-5 |
|---|---|--|---|---|---|
| Occurrence | Hardness less than specification | Heat Treatment Furnance Fan suddenly Off &Quenching tank not clean, | Furnance Fan bearing jam | air circulation not proper | |

| | Cause | Countermeasure | Tgt. Dt. | Status |
|---|---|---|---|---|
| Supplier End | <occurrence></occurrence> | 1.Fan Bearing changed & its Life monitoring started. 2. Fan check point added in heat Treatment WI. 3. Water tank cleaning frequency changed to weakly. 4. Tank cleaning check point added in heat Treatment WI. | 15.09.2024 | Completed |
