Customer : M/S.ETL

Part No. : S2HT521070

Part Name : OUTER SPRING (K0PG)

Report Outline

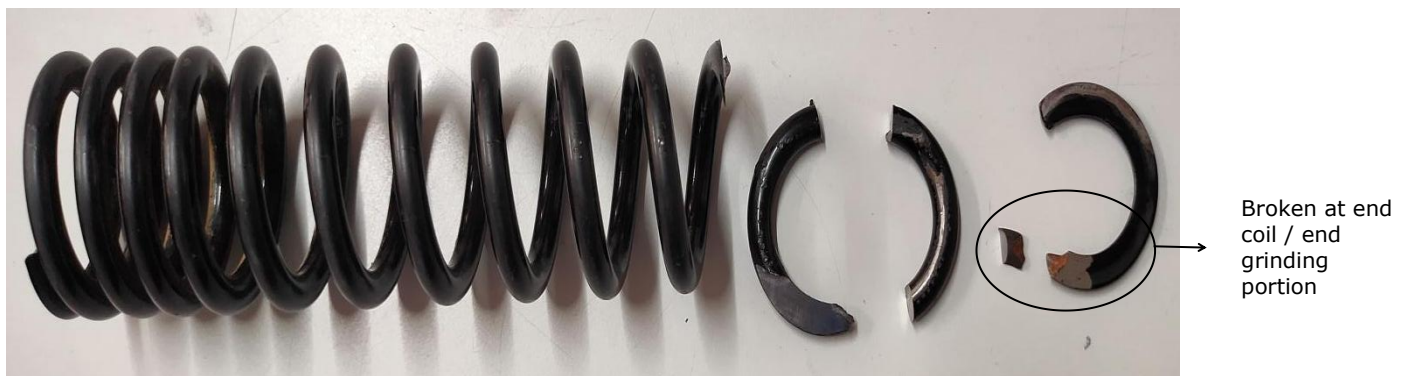
One of the field failure outer coil spring received from customer end for failure analysis, As received condition photograph of failed spring is as shown in photograph 1. The spring in the as received condition found to be with rusty in condition in several portions including fracture faces, and also with powder coating peeled off.

Photograph 1: As received photograph of the broken spring and broken at end coil from one end.

1. Refer photograph no 1,7-8 and 11-13 for the as received condition of failed spring, which was found to be in rusty condition in both fracture face. It is also evident from the above photographs that, the peeled off condition of powder coating both at fracture & adjacent locations and several mechanically damaged portions due to abuse of the springs.

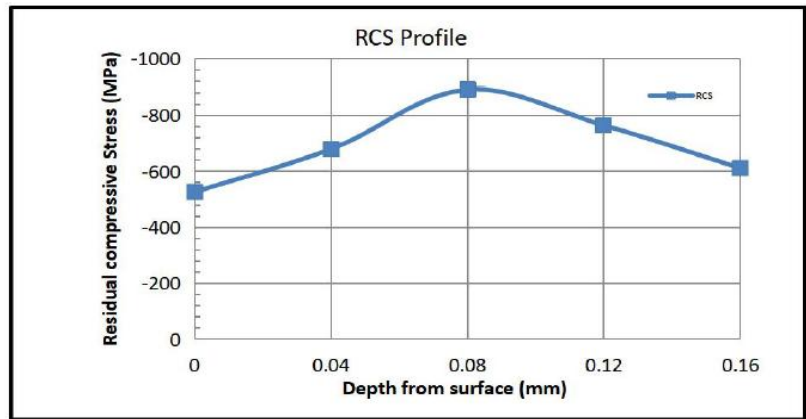
5. The shot peening coverage at other portion of the spring found to be satisfactory and hence the compressive residual stress found to be satisfactory. (Refer photograph no-10 & Table:1).
6. The EDS results ruled out the presence of any non metallic inclusions or slag entrapment's, which could be carried from basic raw material used (Refer photograph no-6).
7. Metallurgical properties like microstructure, decarb level and hardness for the failed spring found to be satisfactory (Refer photograph no 14-15).

The surface and peak residual compressive stress follows -526 & -892 Mpa. Which is satisfactory.

Depth from surface (mm)	RCS (MPa)
0	-526
0.04	-680
0.08	-892
0.12	-765
0.16	-612

Table 1: Residual compressive stress values and graph

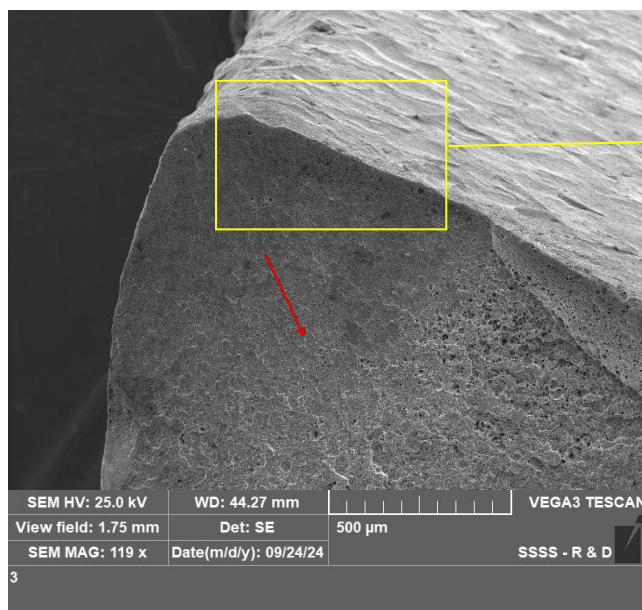
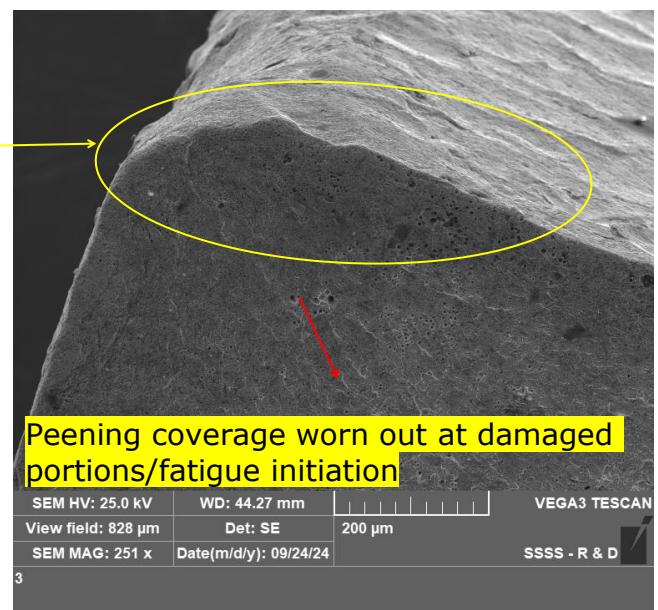
2. The fracture location is identified at the end coil, that is grinding portion of the spring. The failure mode appears to be premature fatigue failure and fatigue initiated from the surface in between spring ID and OD and propagated further towards core. (Refer photographs no 2-5 & 7-8).

3. At the fatigue initiation site the spring surface found to be powder coating is peeled of in condition and mechanically damaged and formed notch type dent (refer photograph-9) and shot peening coverage has worn out , which confirms that, the damages was occurred externally after the spring manufacturing. Due to the formation of notch type dents in between ID and OD surface, which has acted as a stress raiser during the application and caused fatigue initiation (Refer below photograph no 2-5 & 7-9).

Photograph 02-03: Fracture face :1 Premature fatigue failure and shot peening coverage worn out at the damaged location/initiation (10X)

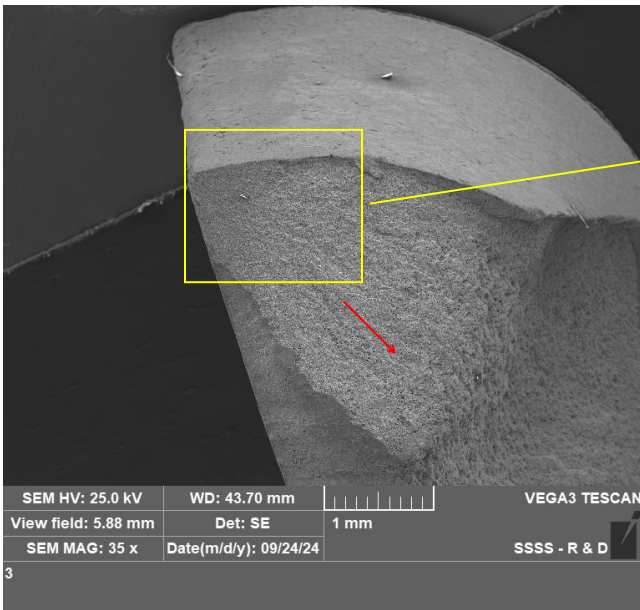
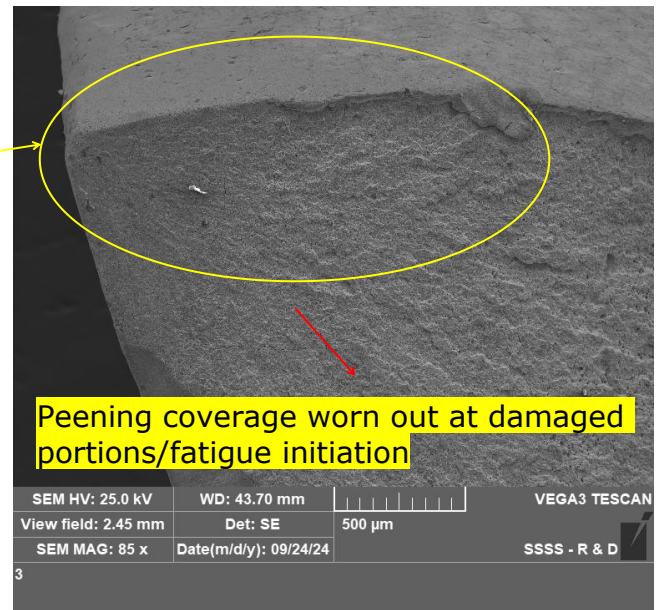
Photograph 04-05:Fracture face:2 Premature fatigue failure and shotpeening coverage worn out at the initiation (10X)

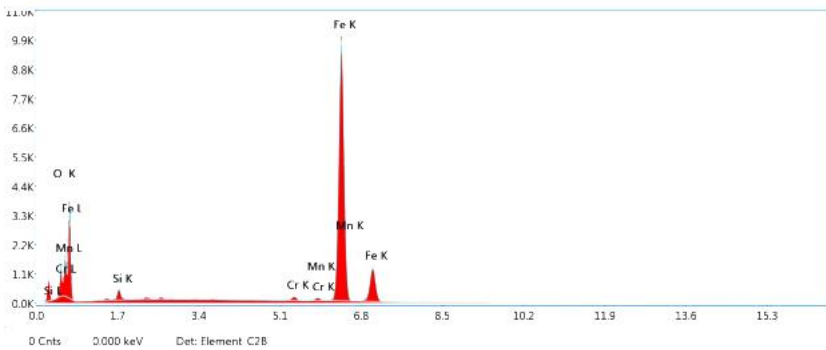
Element	Weight %
O K	4.14
SiK	2.10
CrK	1.01
MnK	0.72
FeK	92.03

Photograph no 06: Free from the non metallic inclusions and material abnormalities

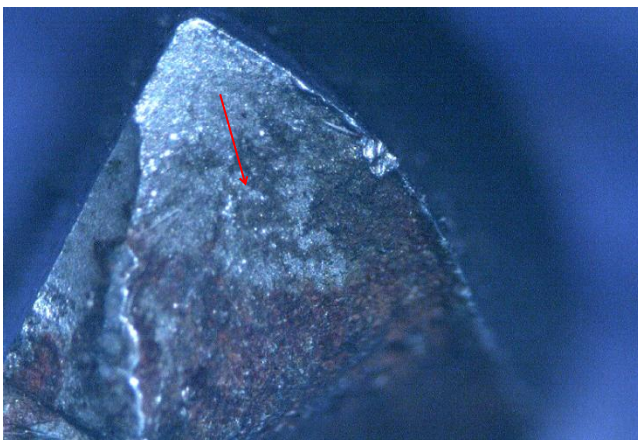
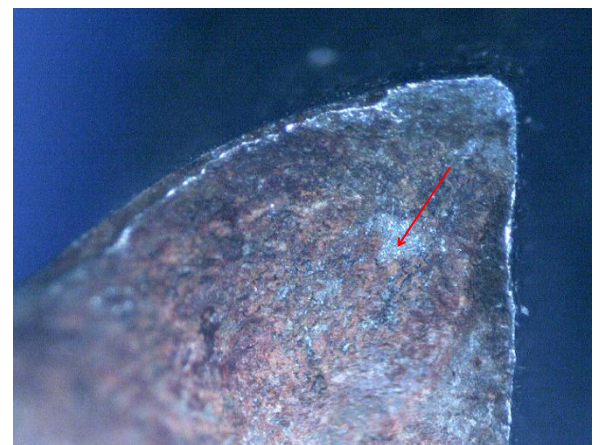
Photograph 07 & 08: Stereo microscope of fracture initiation and rusty condition of fracture faces (10X)

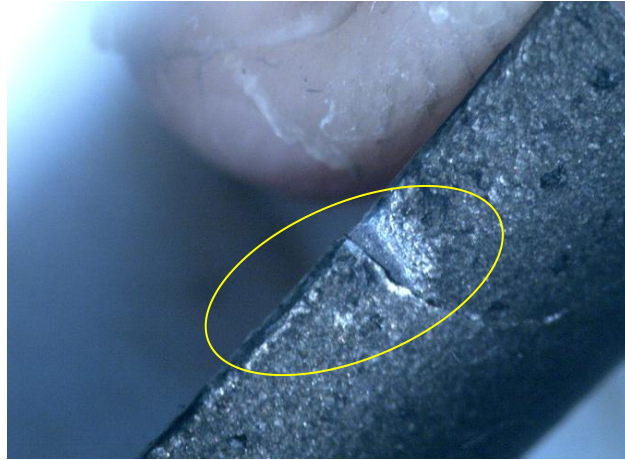
Failure mode appears to be premature fatigue failure and the root cause for the fatigue initiation found to be due to the presence of external notch type damage /dent in between spring ID & OD, which appears to be acted as stress raiser during the application and resulted in breakage.

Photograph 09: External mechanical damage/notch type dent and worn out of shot peening coverage (10X)

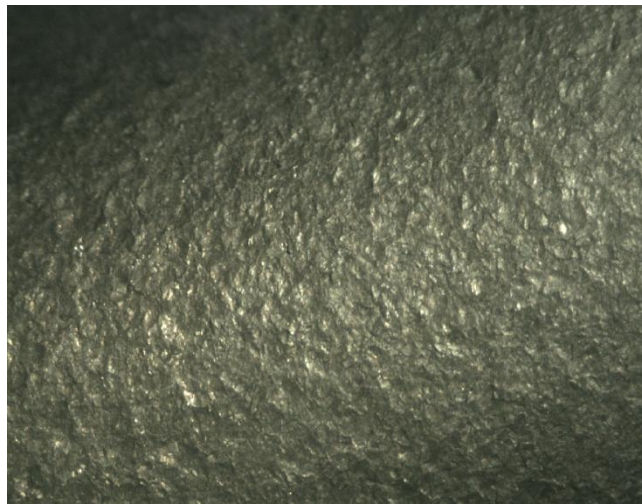
Photograph 10: Good shot peening coverage at other portion (10X)

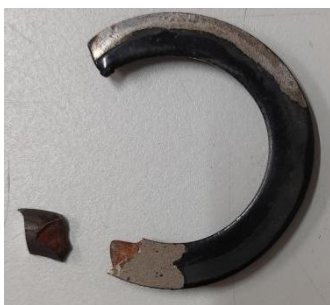
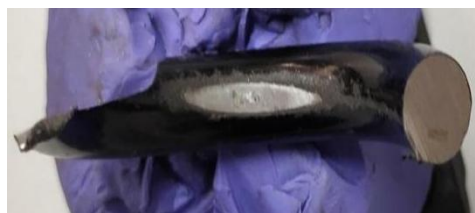
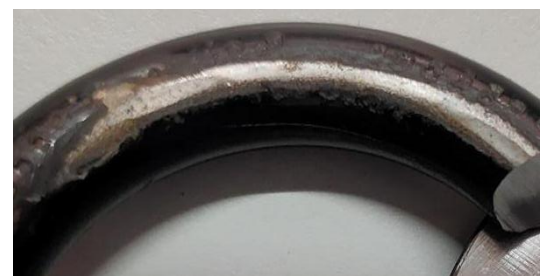
4. The fracture faces and adjacent locations are found to be in rusty condition including mechanically damaged portions along with extensive mechanical damages / powder coating peel off due to abuse of spring externally (Refer below photograph no 11-13)

Photograph 11,12 and13: Fracture face found to rusty in condition and adjacent coil found to be with extensive mechanical damage/worn out and powder coating peeled off in condition.

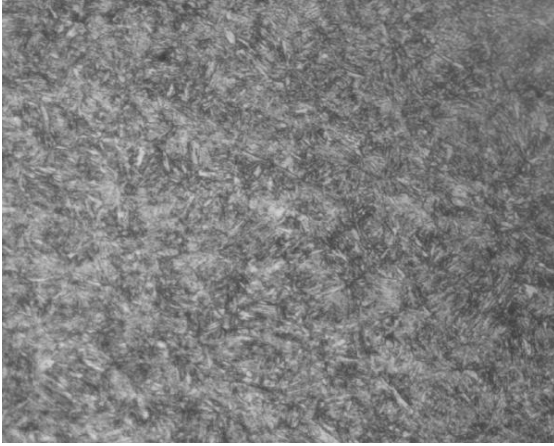
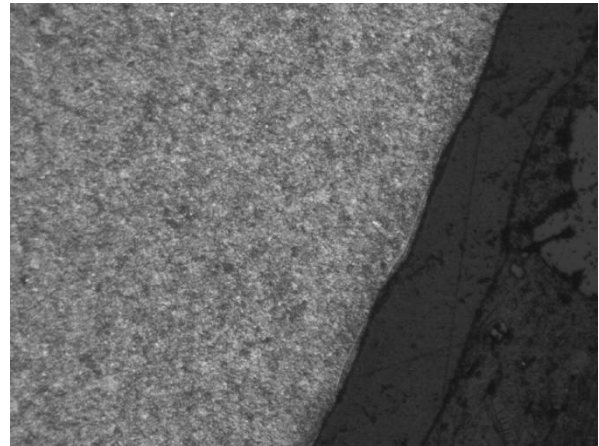
1. Microstructure of failed spring at 500x is tempered martensite for failed spring (Refer photograph-14).
2. Material is free from any decarburization (100X). (Refer photograph-15).

Photograph 14-15: Tempered Martensite (500X) & Nil decarburization (100X)
