Corrective Action: Occurrence - Pad Separation Concern 520BS01006 Frt LH Pad

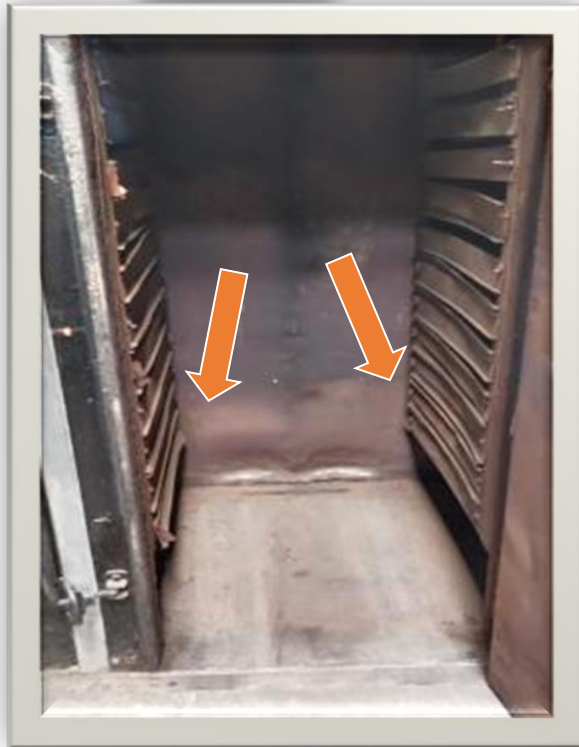
Before

| TYPE | Identified Root Cause | Corrective Action | Resp | Target Date | Status |
|---|---|---|---|---|---|
| Occurrence | Due to presence of relief in bottom side of single chamber baking oven , Fallen parts might have lodged in the corner of oven and missed during collection using magnetic trolley | Relief in all single chamber ovens will be covered with mesh in order to prevent part entry into the corner of the oven | PED | 20-10-2024 | Completed |

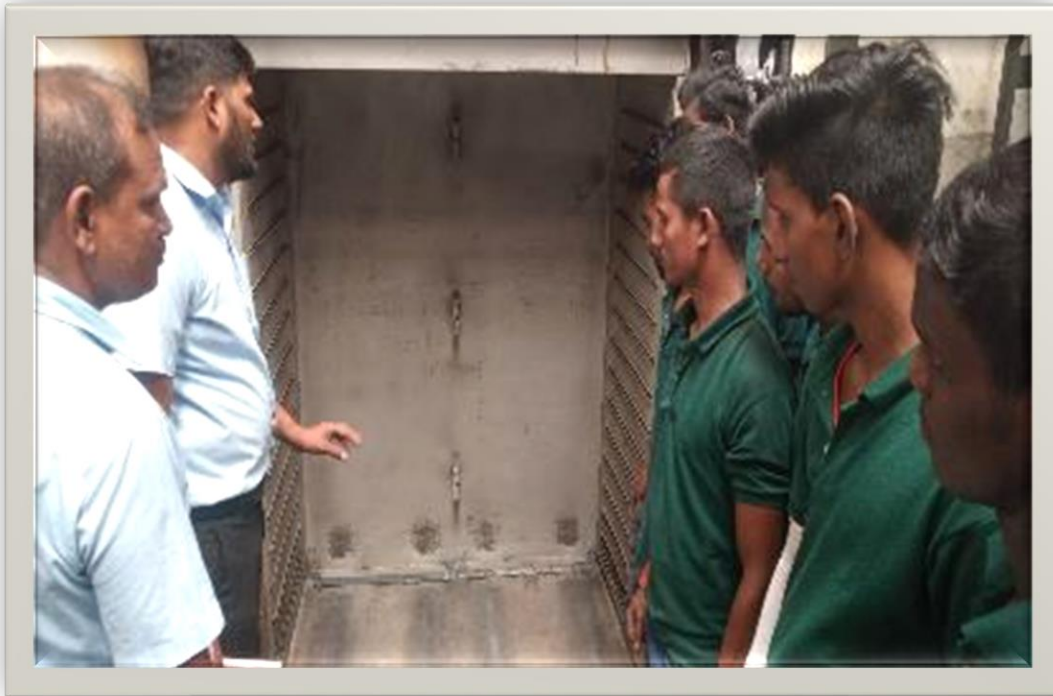
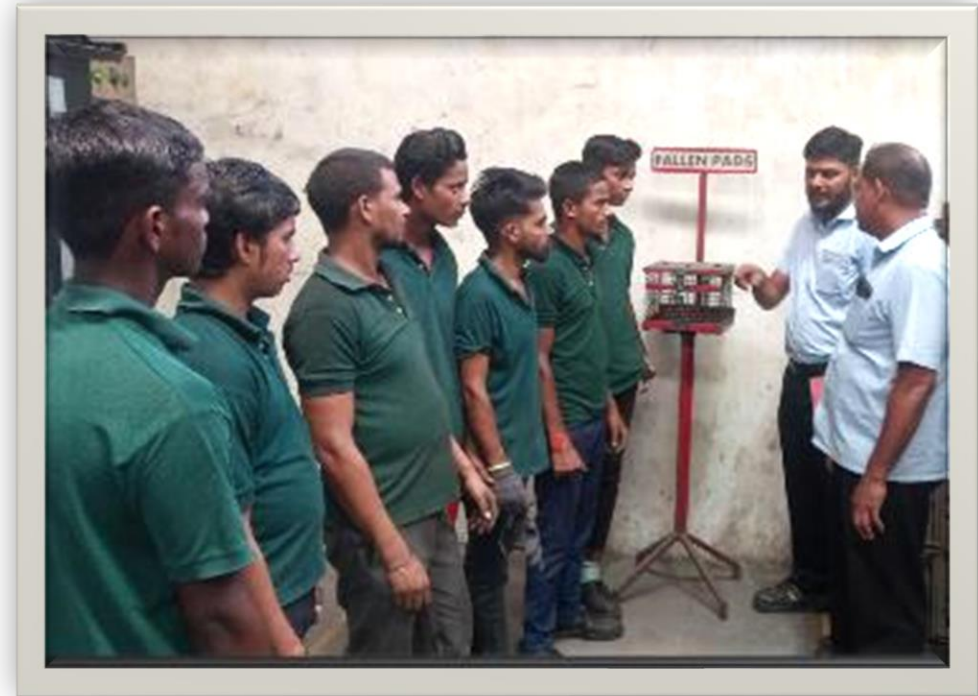
| TYPE | Identified Root Cause | Corrective Action | Resp | Target Date | Status |
|---|---|---|---|---|---|
| Occurrence | Due to lack of awareness on over baking fallen part mixed up with regular batch | 1) Awareness provided to baking operators on fallen part collection and handling 2) Fallen part verification will be done by quality team on daily basis | QAD | 03-10-2024 | Completed |

Fallen Part Handling Awareness Provided to Baking Operators
