TUBE PRODUCTS OF INDIA SHIRWAL

41.20x36.40-ETL-PIT MARK ANALYSIS

Reason for analysis :- Pit Mark

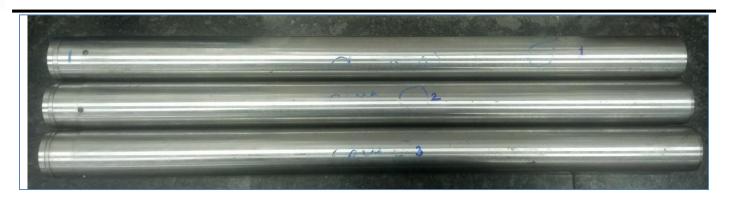
Observations:-

1) Pit marks observed to received samples.

Sample	Defect description	Defect location	Probable cause
1	Flow lines below the defect Pit depth 0.071 mm	Away from the weld	Mechanical damage
2	Flow lines below the defect Pit depth 0.268 mm	Away from the weld	Mechanical damage
3	Flow lines below the defect Pit depth 0.016 mm	Away from the weld	Mechanical damage
