Motor Eccentric

AB AUTO COMPONENTS

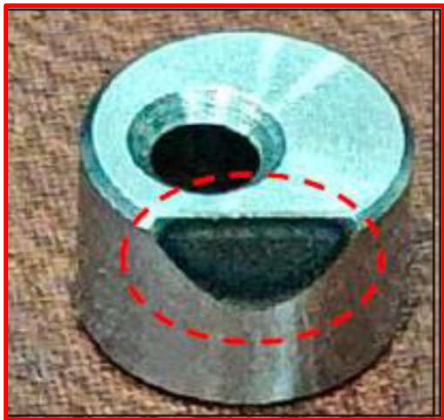
Problem : **Surface Damaged**

- **Occurrence Cause :**
 - While Grinding process parts hit to grinding wheel caused to damaged from the holding cavity.
- **Detection Cause :**
 - Inspection method was in-adequate, group sampling inspection instead of individual parts.
 - Due to lack of awareness for visual inspection.

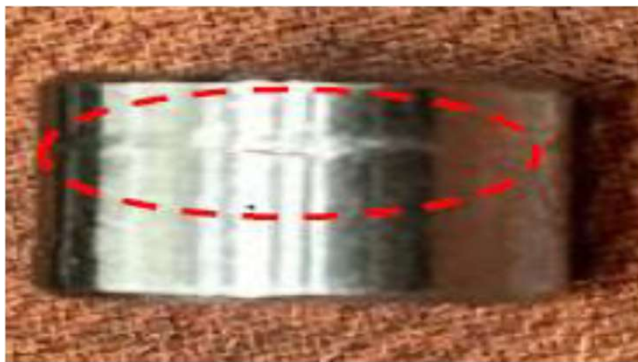
Problem : **Surface Damaged**

- **Occurrence Cause :**
 - While Grinding process parts hit to grinding wheel caused to damaged from the holding cavity.
- **Detection Cause :**
 - Inspection method was in-adequate, group sampling inspection instead of individual parts.
 - Due to lack of awareness for visual inspection.

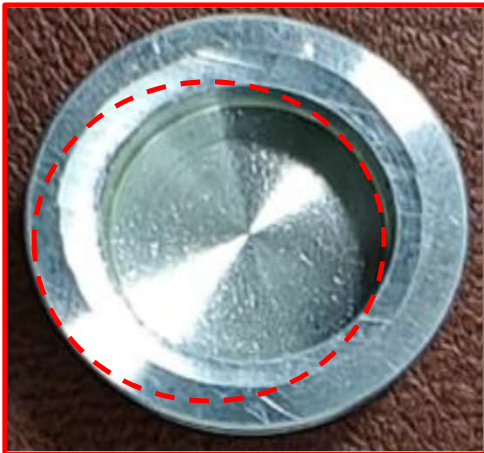
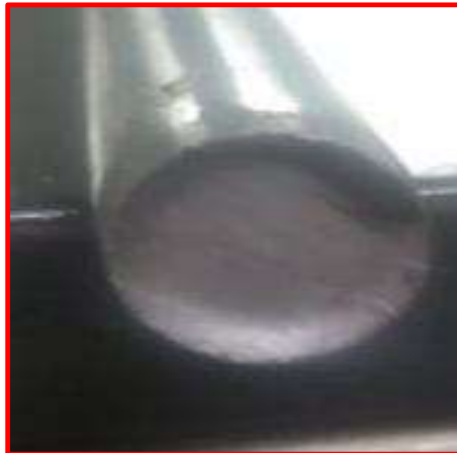
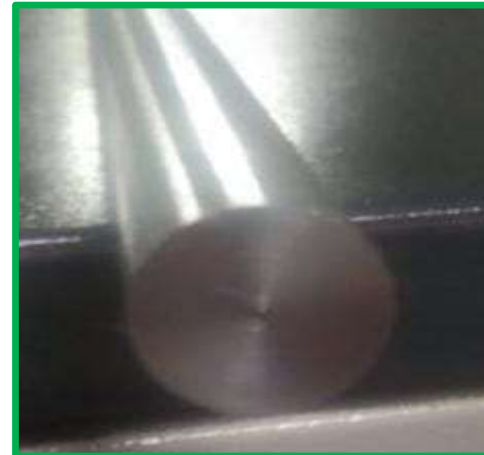
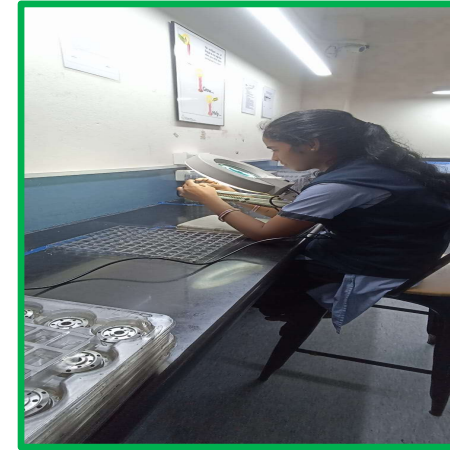
Problem : Face Unclear.

- Occurrence Cause :
- Improper facing for 1st piece of Rod, due to input rod face was uneven.
- Detection Cause :

No limit sample placed at work place as well as final inspection area.

- Occurrence Action :
- Facing process implemented to 'Rod' before loading on machine.
- Detection Action :
- Final inspection started with magnifying glass.
- Visual inspection done by dedicated person.
- 200% inspection started for visual inspection(Process stage & Final Stage).

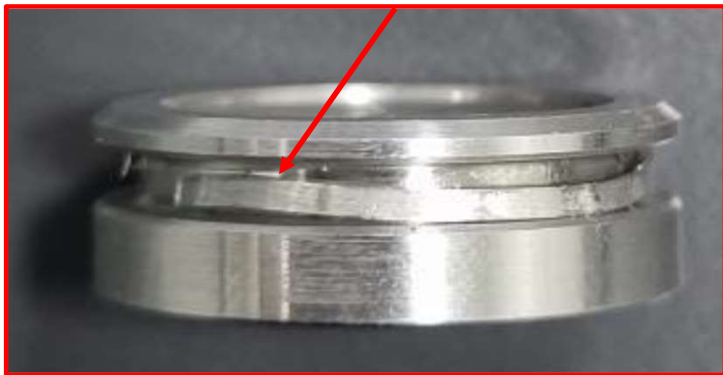
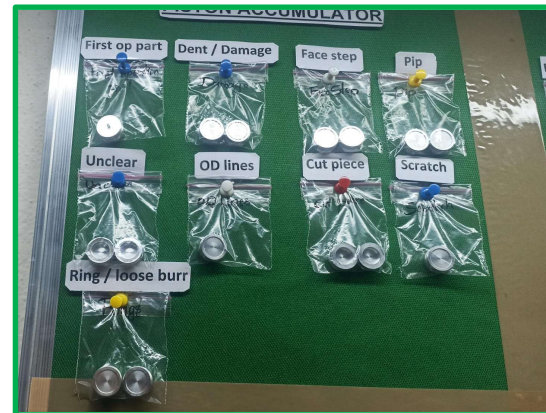
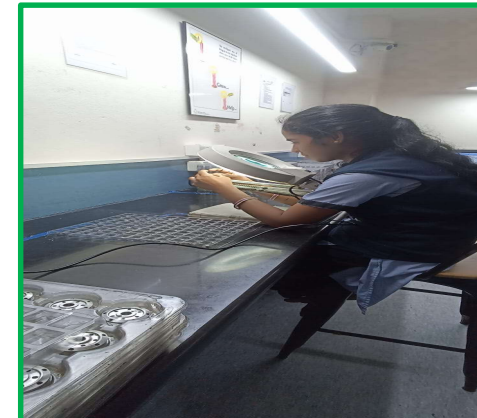
Problem : Loose Burr.

- **Occurrence Cause :**
 - Loose Burr captured during turning process.
 - Earlier using 1mm width insert
- **Detection Cause :**
 - Skipped from final inspection due to group parts inspection.

- **Occurrence Action :**
 - Existing insert planned with 2mm width to reduce process cycle time as well as such defects.
- **Detection Action :**
 - Final inspection started with magnifying glass.
 - Visual inspection done by dedicated person.
 - 200% inspection started fir visual inspection (Process Stage & Final Inspection Stage)
