## TUBE PRODUCTS OF INDIA SHIRWAL

30X28 – Crack sample analysis and Action Plan. Saptagiri Industries Pvt Ltd, Aurangabad.

#### **Complaint details**

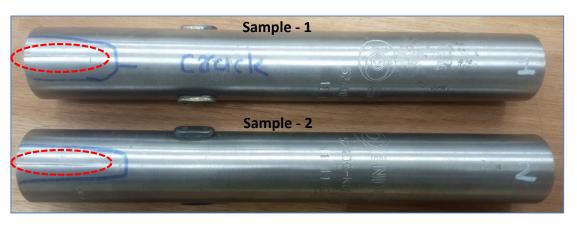
## **Defective Sample photos**

- 1) Crack observed to received samples.
- 2) Pressing mark observed at crack side.
- 3) Batch code date 11.11.2024.
