Poor Rated Supplier -Management Review Meeting

**Supplier Name:-
M/s TIDC**

TIDC INDIA FINE BLANKING	<u>CORRECTIVE ACTION PLAN IN 6 W - 2H FORMAT</u> Month - June 22
---	--

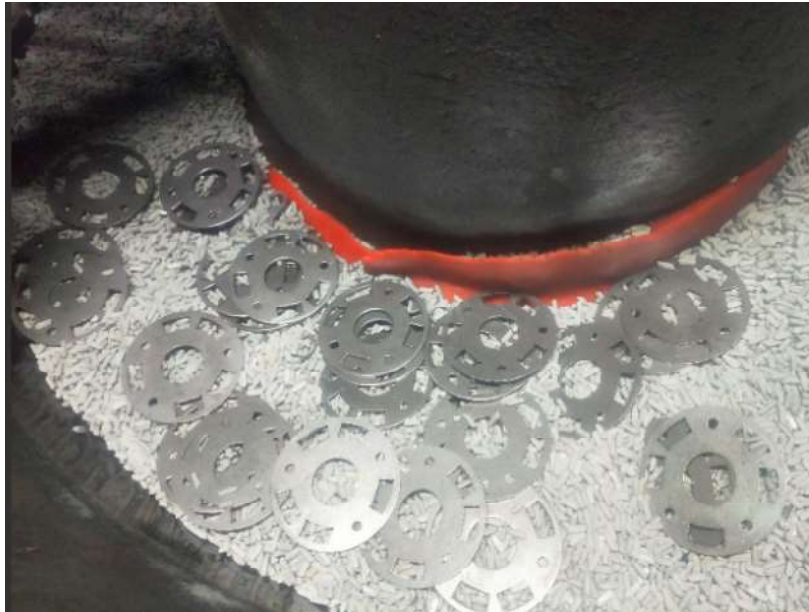
BEFORE

Problem

Parts are sticking each other due to flat surface during vibro process

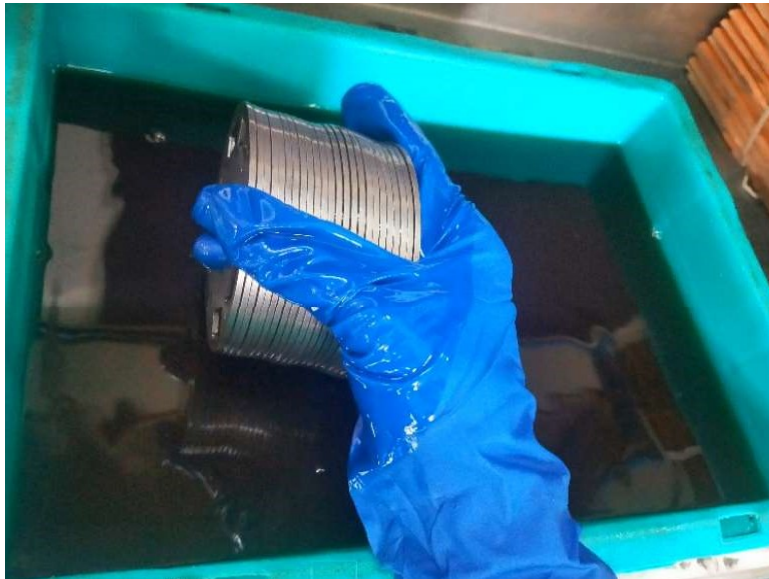
BEFORE

Problem

Parts are Oild in stack condition
