# Inspection Side Before & After

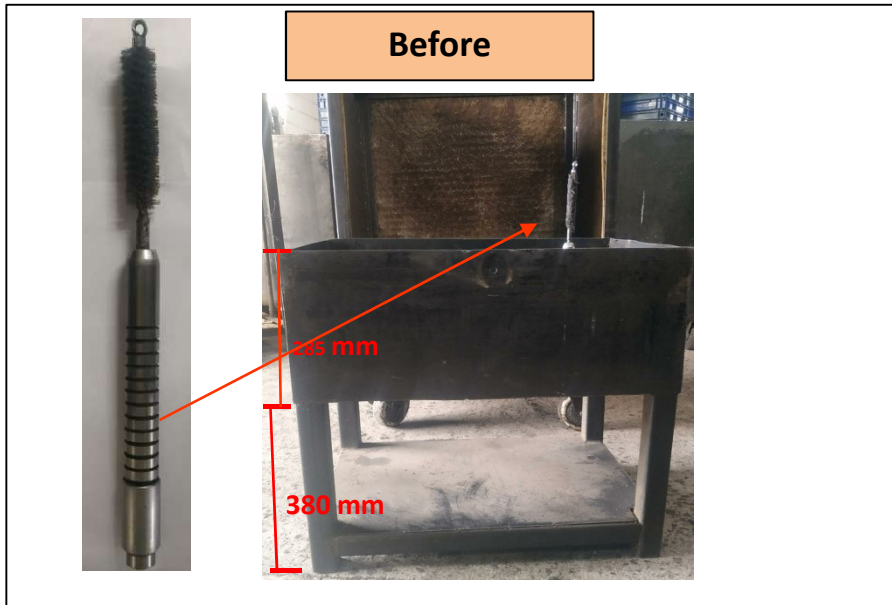
Operator not able detected that Part is fully Inserted & rest at bottom of Deburring Poka- Yoke Fixture Cause of Deburring Fixture Table Height is Less (380 mm ) & Burr Collecting box height ( 285 mm ) is More.
