ACTIONS FOR LINE MARK (WASHER S2PL03812B)

Supplier: **Saptagiri Industries.**

Part Name : WASHER K55G

Part No : S2PL038120

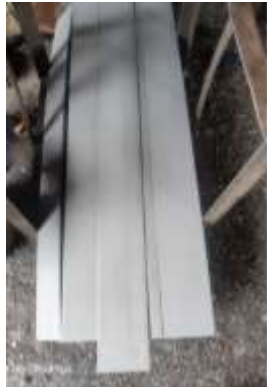
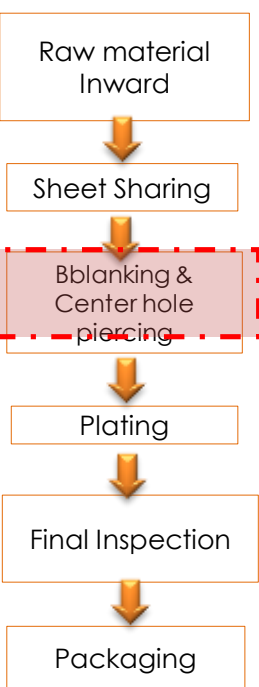
BEFORE

Problem/Present Status: Stamping mark like depth line mark at top surface of Washer K55G.

While blanking operation, sheets' sharp edges draw

Same scratches line mark will generate on parts

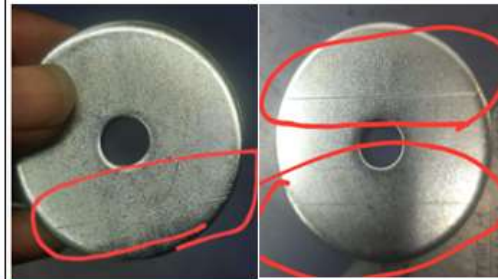
Possible / Reported Defects : DEEP MARK-Heavy line mark, visual defects

No stamping mark, deep mark OR depth line mark at top surface of Washer K55G.

Stamping mark like depth line mark at top surface of Washer K55G.
