GPH Defects & Action Plan By M/S Sanjeev Auto

- Prepared By:- Mr. Dhananjay Nilangekar
- Reviewed By:- Mr. Vijaykumar Wankhede

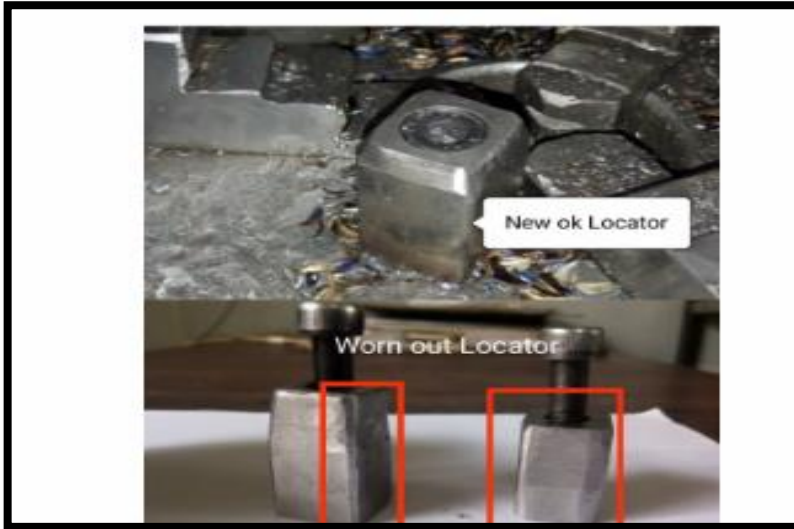
Defect Bush Shift:-Slot Shift

1. Worn Out Locator Changed

1. Worn Out Locator Changed & Height of Locator Reduced
2. Additional Relief given to slide job in Locator freely, Fit Locator may cause to sit job in Tilted Position.
3. Play In Locator & Window of Job reduced to 0.1mm.
4. Both of the Slot Milling-1 & Slot Milling-2 machines, Driving Gear of Ball Screw Changed
5. Slide Movement- Play In Slide , Considerably reduced while milling operation.
6. Jaw boring done to "True" Jaws.
7. New Symmetricity Gauge manufactured for setting –Approval & process Inspection.

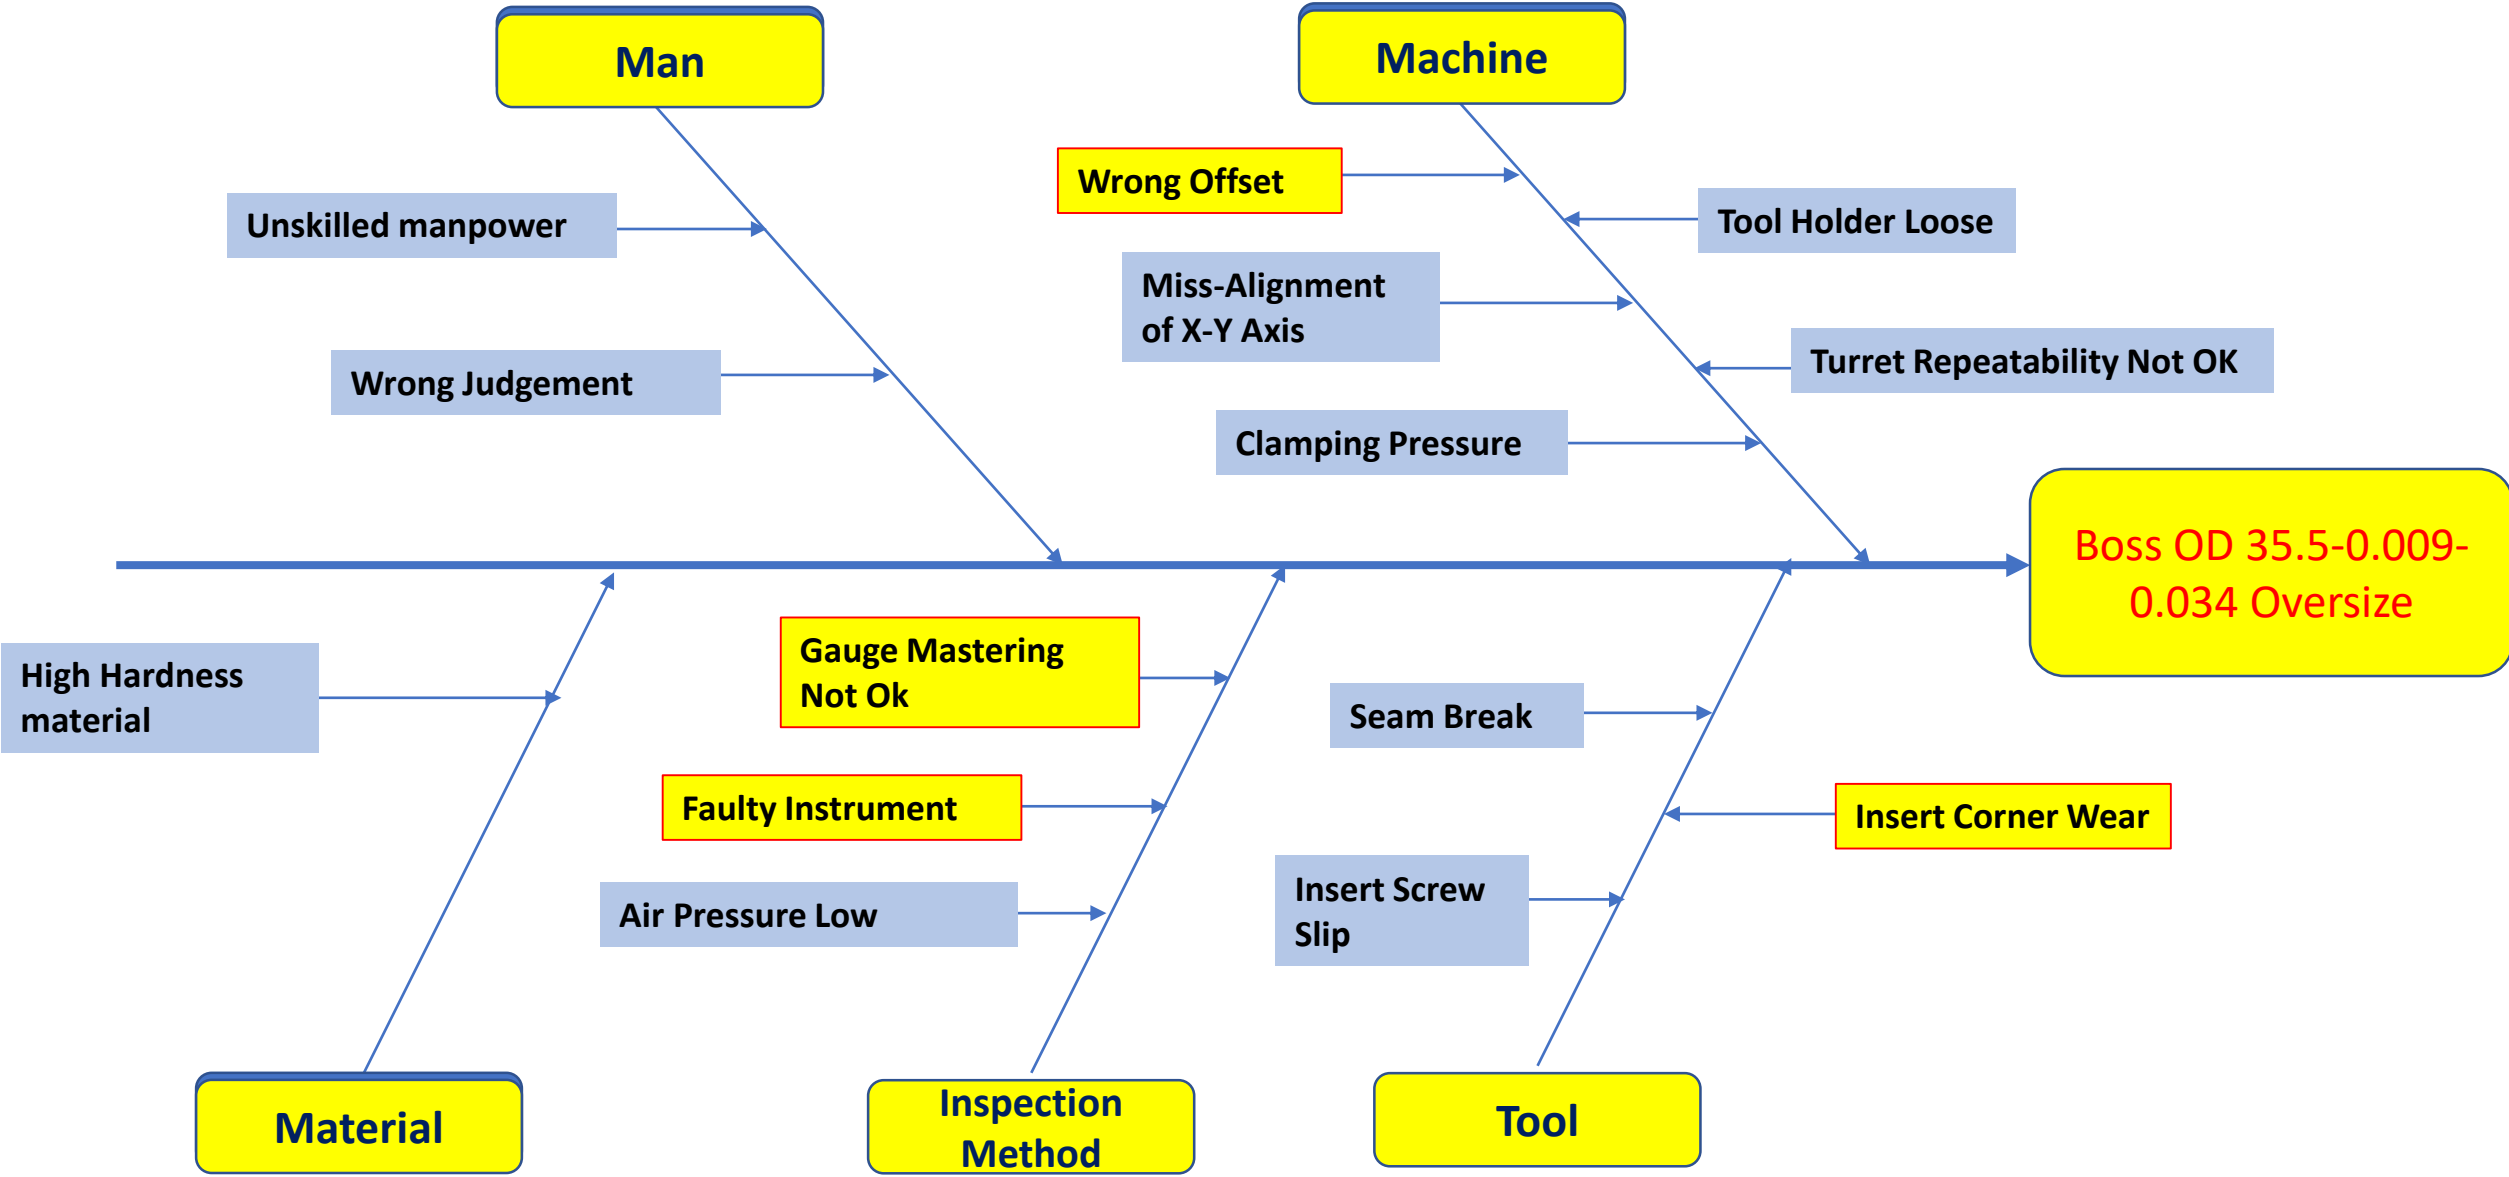
Fish Bone Analysis

**Defect No-02:-OD Oversize 35.5-0.009-0.034
Defectives-148**

Sr No	4MT	Possible Cause	Corrective action	Preventive action	Sustenance Action
1	Machine	wrong Offset	Training Given to operator	offset Interlock Provided on Machine	JH Check sheet
2	Inspection	Faulty APG	New APG Added	Carbide Ring to Introduce at Final Inspection (Attribute Gauging)	JH Check sheet
3	Inspection	Mastering Not Ok	Training Given to operator	Master Sample Prepared for Gauge Validation every 15 job.	SOP Prepared
4	Tool	Insert Corner Wear	Tool Life Monitoring	Tool Life Interlock	JH Check sheet

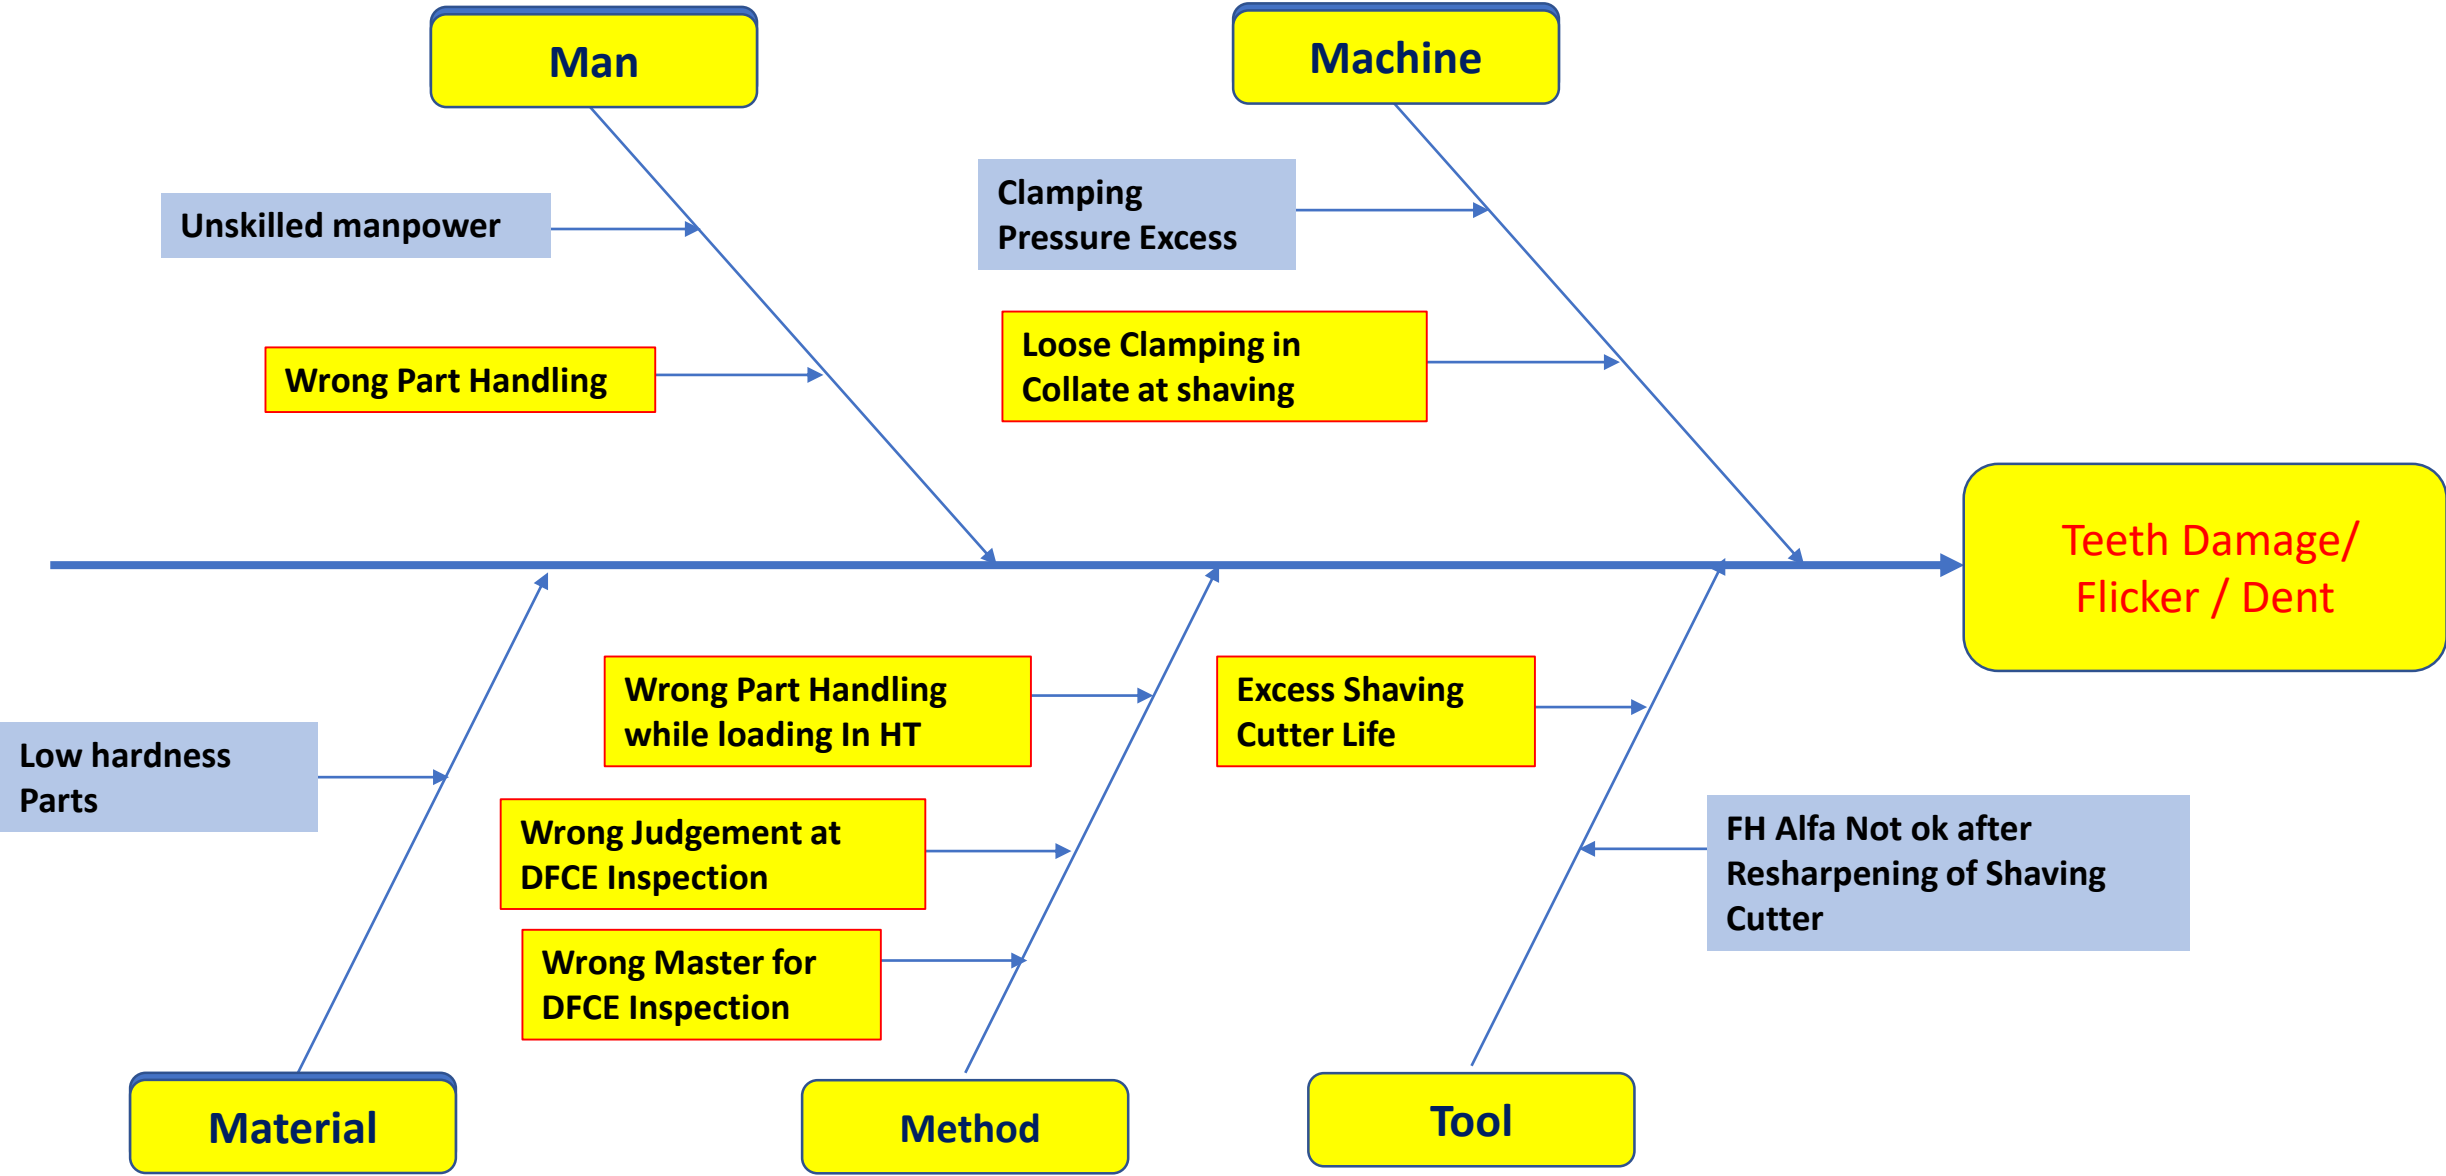
Fish Bone Analysis for Dent-Flicker

**Defect No-04:-Dent Mark/ Teeth Damage/ Flicker
Defectives:-59**

Sr No	4MT	Possible Cause	Corrective action	Preventive action	Sustainance Action
1	Man	Wrong Part Handling	Training Given to Operator	SOP for Material Handling Prepared & Dispalyed	Sustainance Through JH Check sheet
2	Method	Metal to Metal contact while loading parts in HT	Training through One point lesson	Daily monitoring	Sustainance Through JH Check sheet
3	Method	Metal to Metal Contact Due to Broken Bin	Broken Bin eliminated from Cycle	All ok Bins are in circulation.	Sustainance Through JH Check sheet
4	Inspection	Wrong Judgement	Traing Given to Operator	Master Sample to be prepared	Sustainance Through JH Check sheet
5	Inspection	Wrong Master for DFCE Inspection	Training through One point lesson	Master Sample to be prepared	Sustainance Through JH Check sheet
6	Tool	Excess tool life of Shaving Cutter	Tool life Re-Monitoring started for Freezing	Daily 100 % Inspection after Shaving by Operator	Check point In Process Inspection

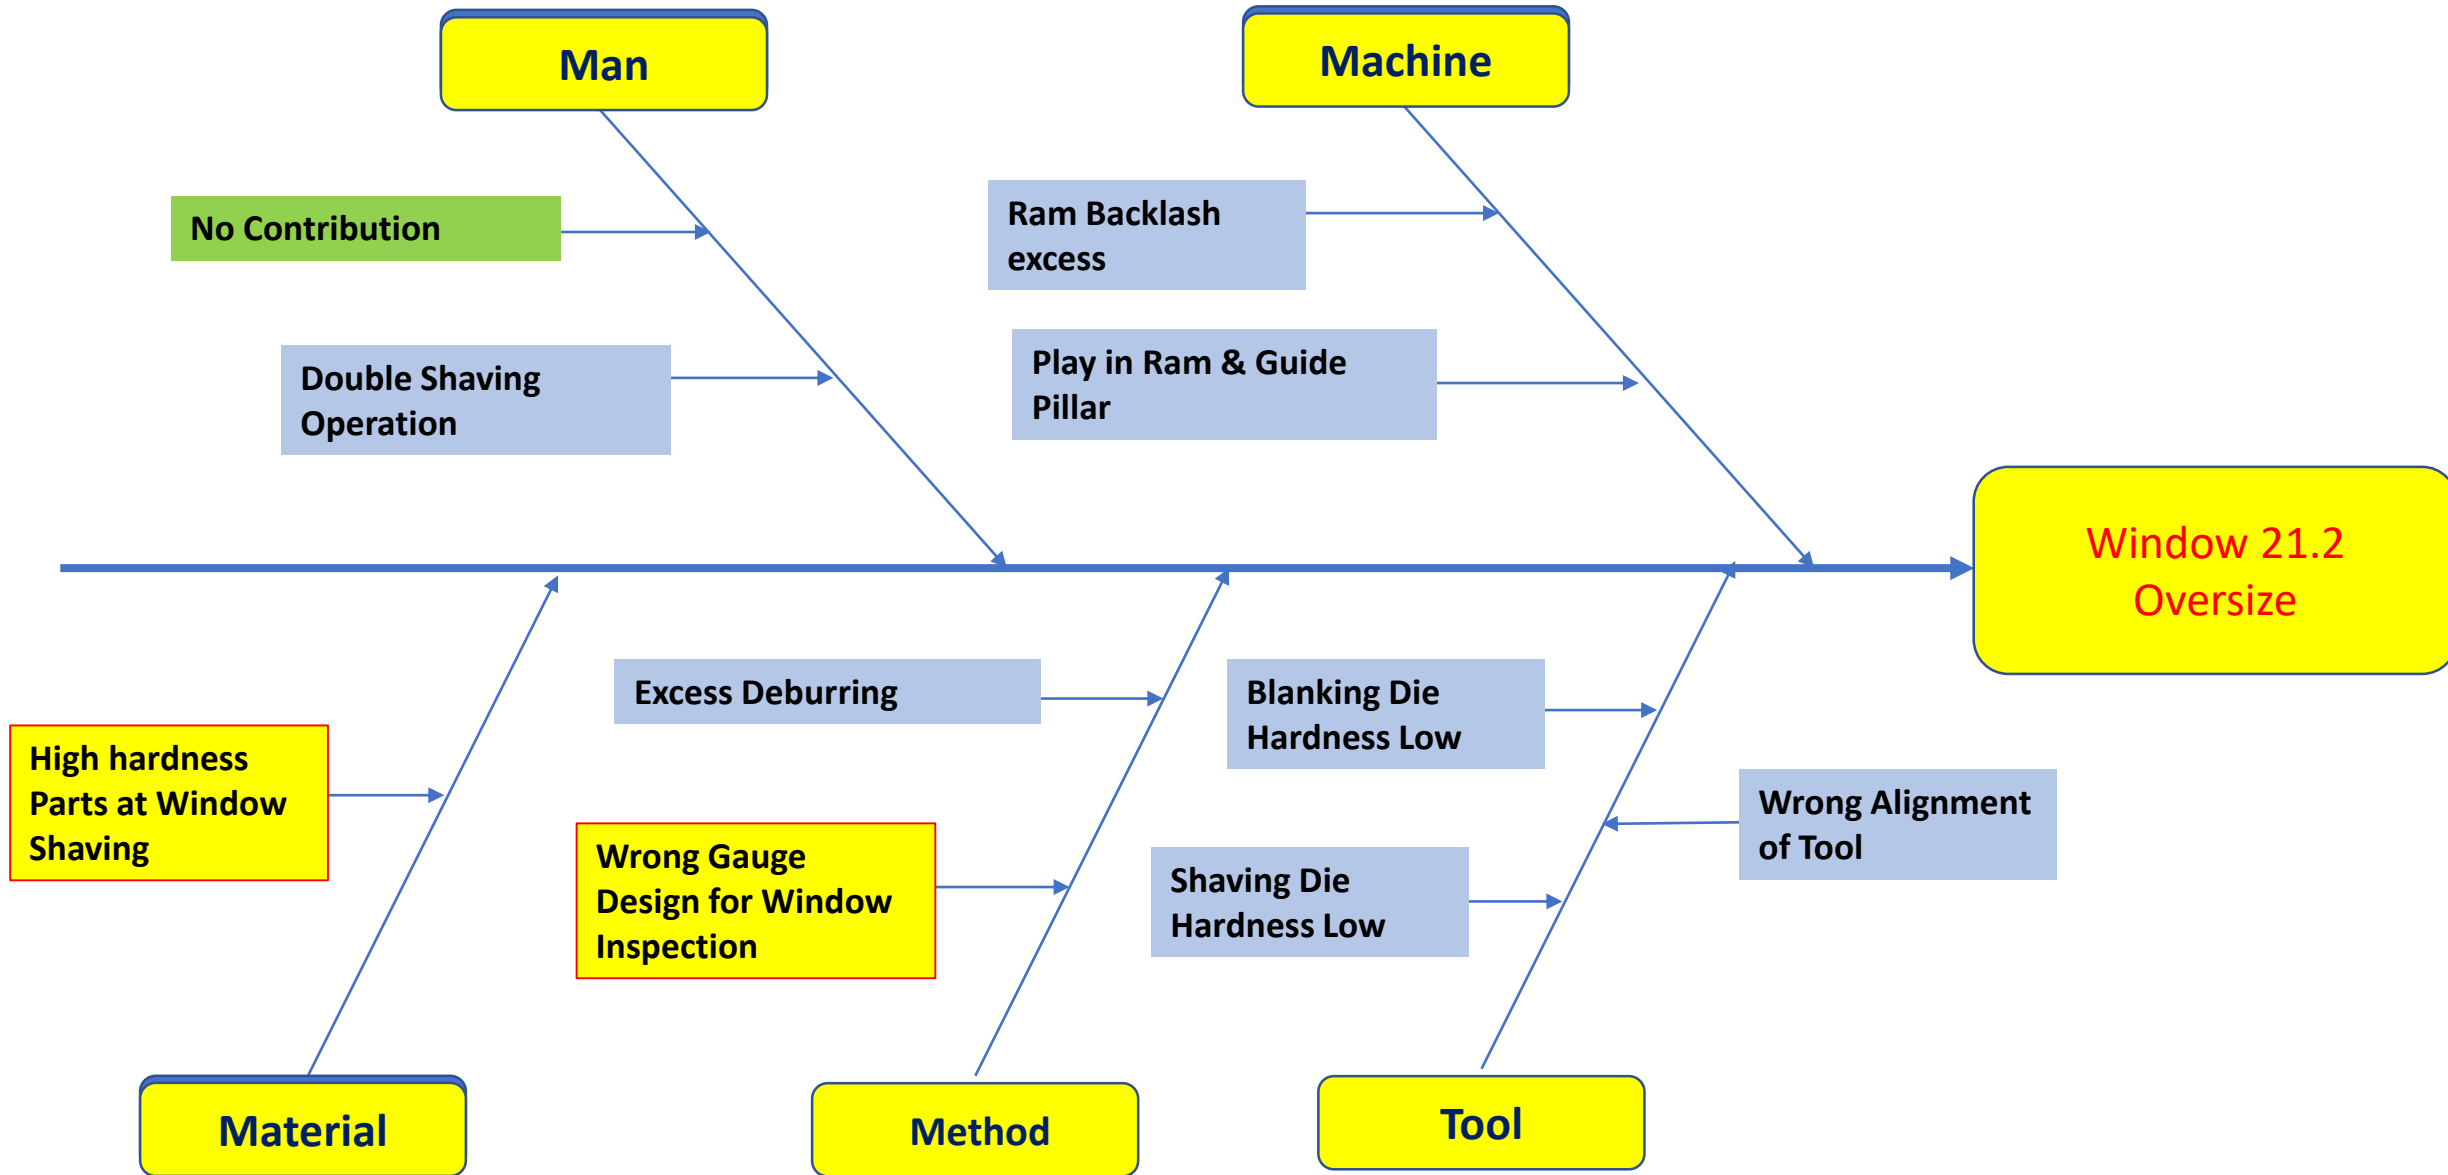
Fish Bone Analysis for Window Oversize

Defect No-06:- Window Oversize
Defectives:-44

Sr No	4MT	Possible Cause	Corrective action	Preventive action	Sustainance Action
1	Material	High Hardness of Parts at Piercing & window Shaving Operation	Hardness Inspection at every 200 nos started	Action Taken at Normalising process for Part Mix up & High Hardness	Process audits
2	Method	Wrong Gauge Design (Combined No Go Gauge for Length & Width of Window Does not Arrest width Oversize Parts)	Gauge Design Changed.	New Standrd Slip Gauge Introduced for Window width Inspection	Reciepth Inspection Report
3	Inspection at Process	Combination Gauge PCD+Width used for inspection can show only Go Result. So Oversize parts did not arrested by Gauge	New Separate Plug Gauge of window 21.2 & Window 18 Introduced for Checking Go / No-Go Width	<p>A. Process Inspection Frequency increased.</p> <p>B. Both Variable & Attribute Gauging Started.</p> <p>C. Three Stage Inspection for Window Started.</p> <p>1. At Press Operation Process 100%</p> <p>2. At CNC Supplier final inspection 100 %</p> <p>3. At CNC Part Inward Sampling Basis</p>	Through Process Audits at Supplier & Receipt Inspection Report
