Action plan

- **Phenomenon:** Welding line open parts.

- **Supplier:** Endurance tech.
- **Model:** Kawasaki
- **Parts name:** Adjuster
- **Part No.:** S2AB044120
- **Date of Occurrence:** 13.02.2023
- **Qty NG:** 4000 Nos.

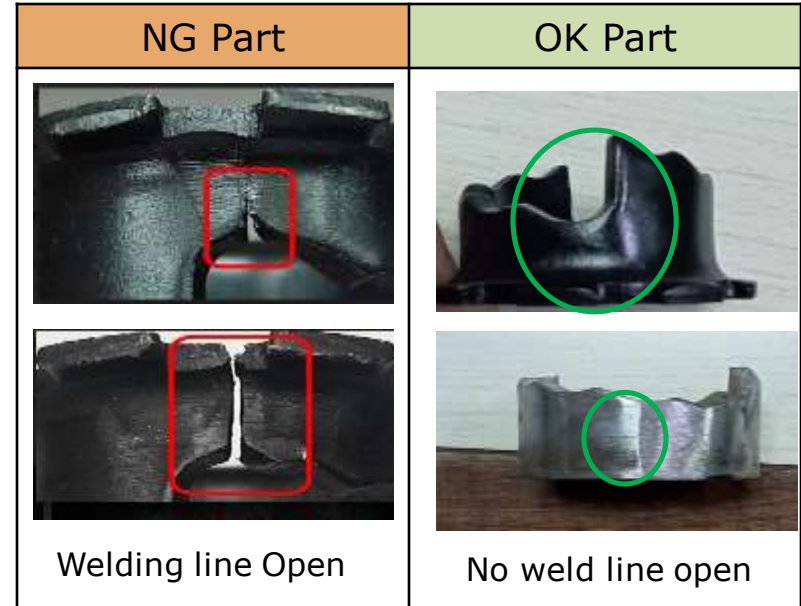
Trouble content

Area	Total Stock	Checked	Checking Method	NG Qty	Status
ETL – K120	4000	4000	Visual check	4000	All available stock qty. Rejected

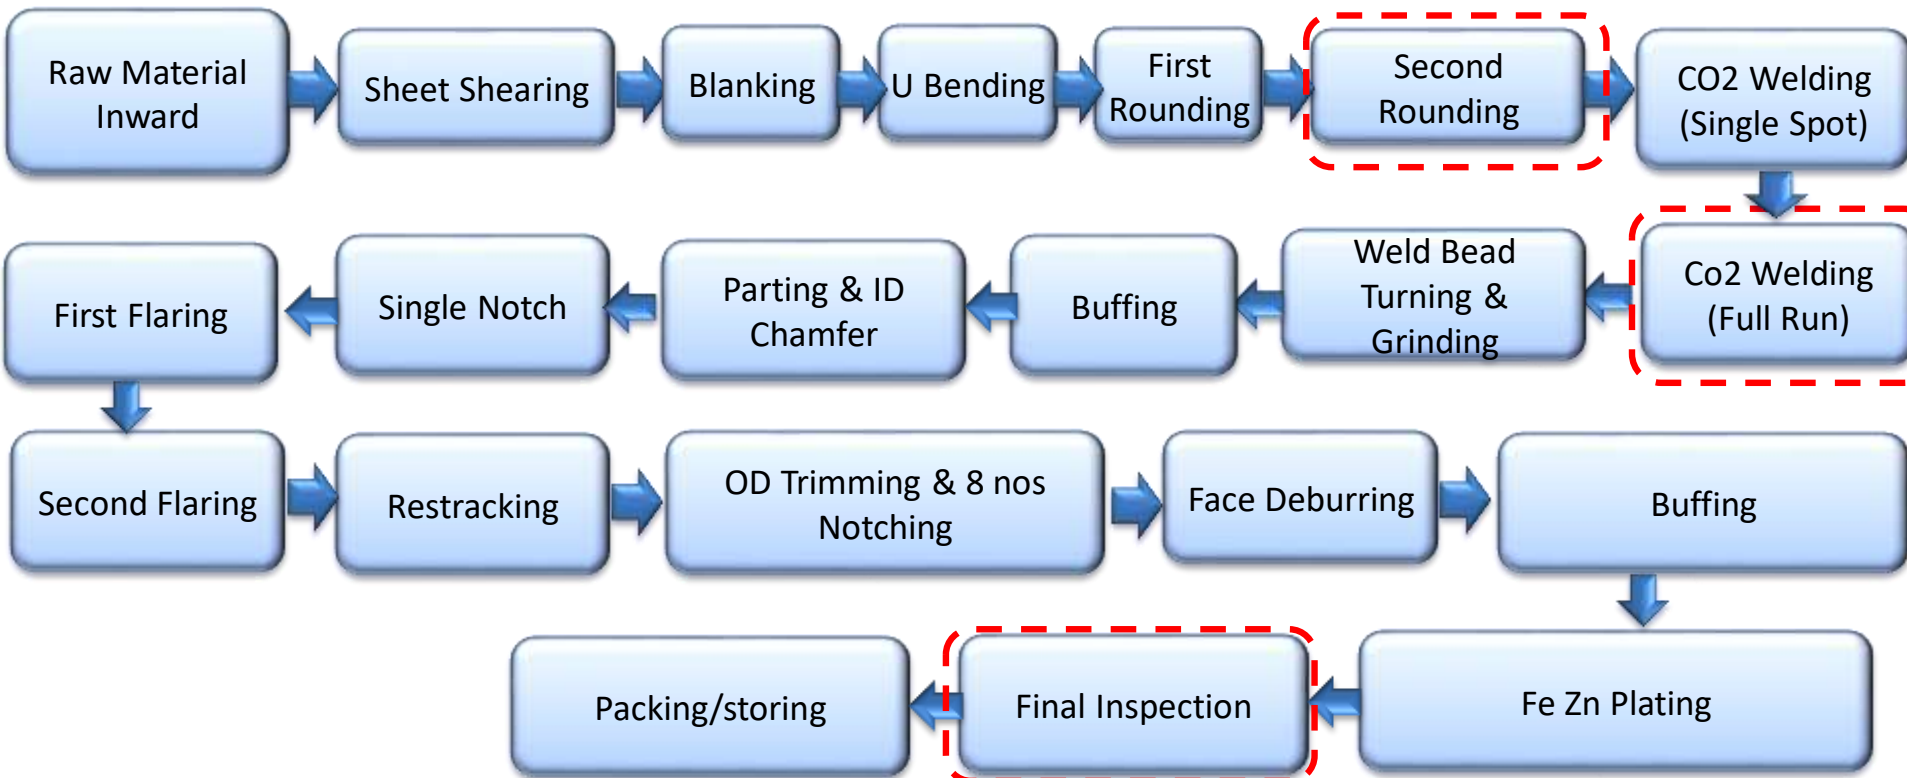
Possible defect occurrence area.

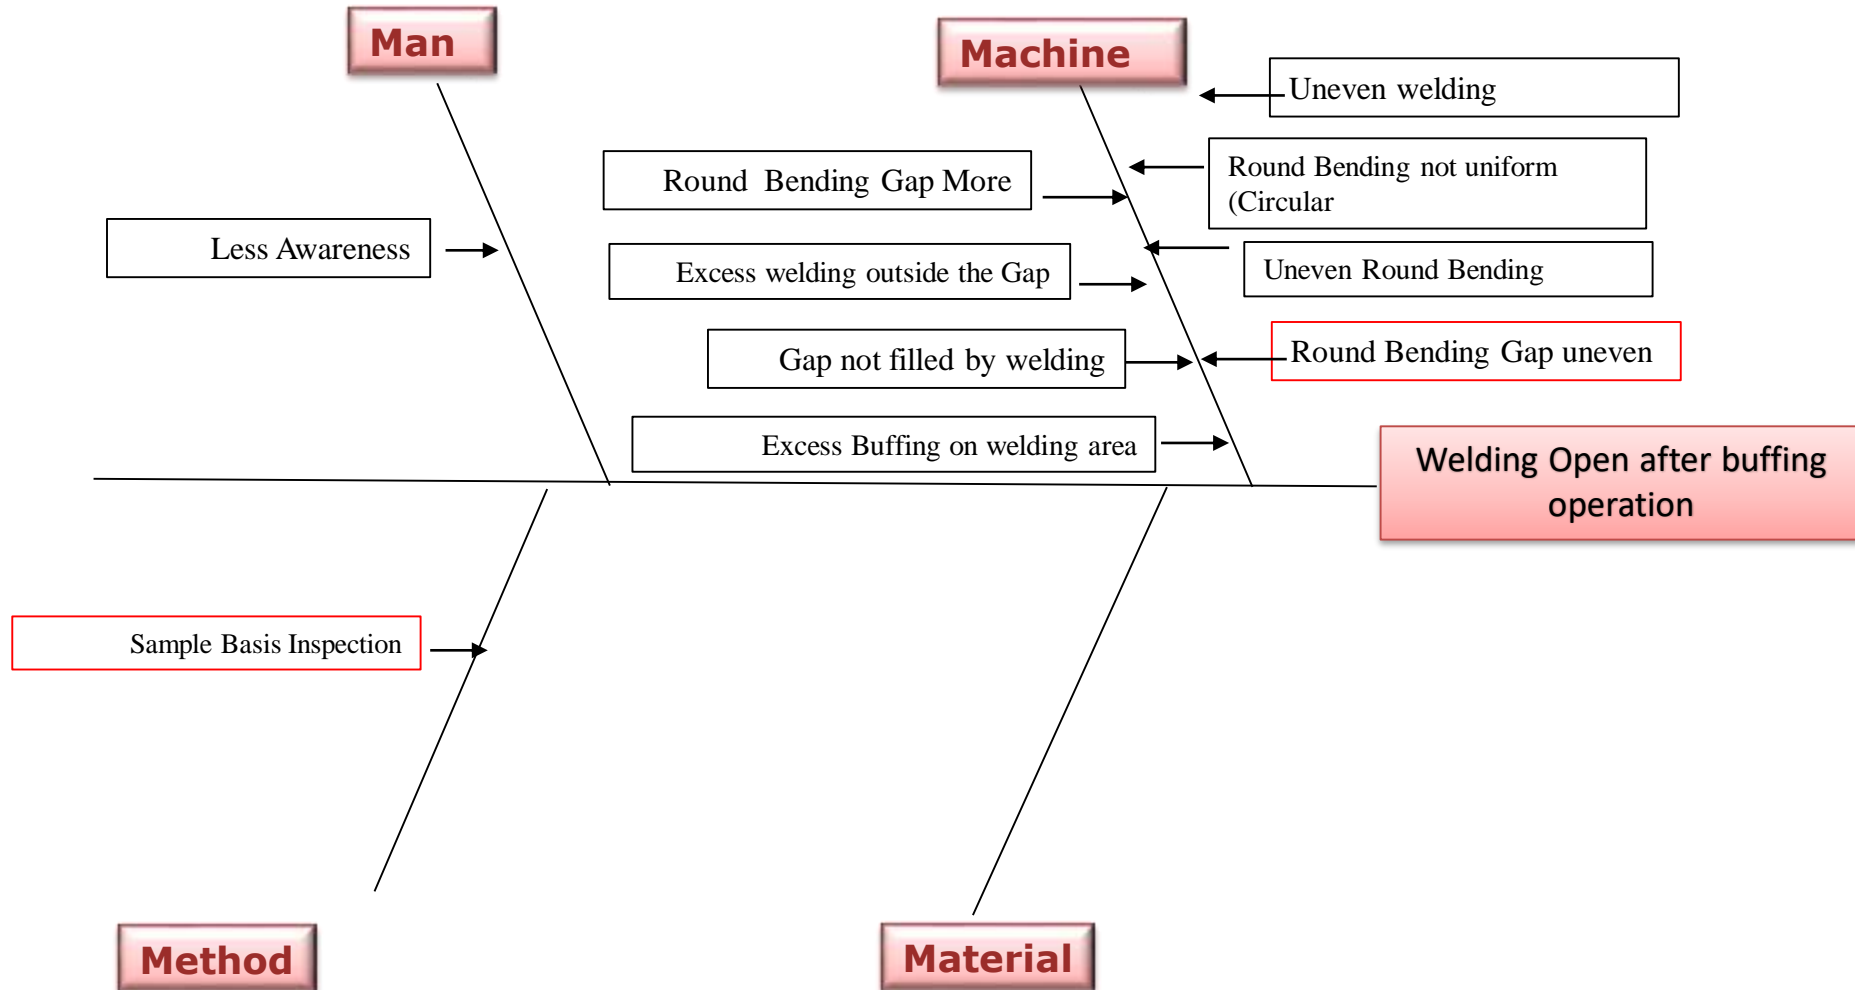
• Understanding the actual cause – (Factor analysis)

#	3M	PROBABLE CAUSES	FACTS VERIFICATION	Jud.
1	MAN	Less Awareness	Operator and inspector not aware about the weld line open	○
2	MACHINE	Round Bending not uniform (Circular)	Round bending observe uniform (Circular)	○
		Uneven round bending	Height variation in both side as well as uneven gap	△
		Round bending gap uneven	In a few part observed uneven gap at top side less (0.54 mm) and bottom side more (1.44 mm)	△
		Excess welding outside the gap	No Excess buffing observed	○
		Gap not filled by welding	Gap fully filled by welding operation	○
		Excess buffing on welding bead area	No Excess buffing on welding line	○
		Uneven Welding	Welding run verified and observed evenly (In straight line)	○
4	METHOD	Sample basis Inspection	While welding and buffing operation only do the sample basis inspection	△
