TUBE PRODUCTS OF INDIA SHIRWAL

6TH APRIL- 2022

Customer :- Saptagiri Industries.

Complaint :- Weld Crack.

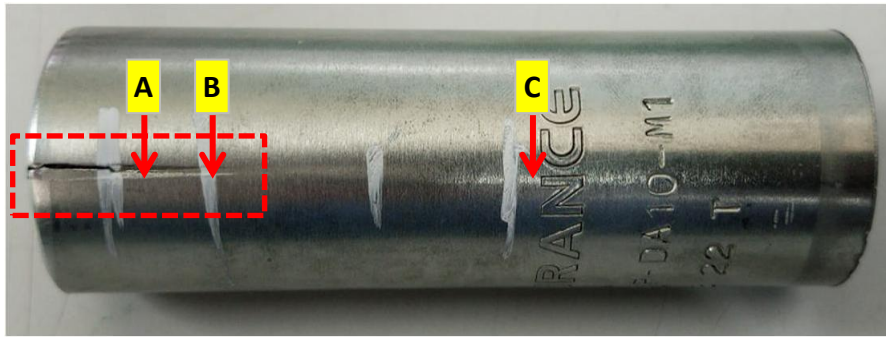
Weld flow A @ Crack_Mag100x

- 1) Weld crack is observed.
- 2) Weld flow is not ok at failed area.
- 3) Crack generated from ID.

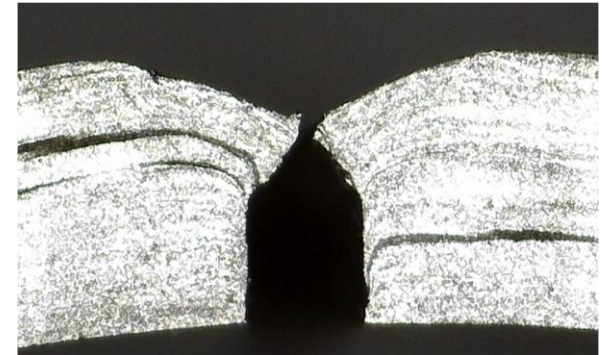
Weld flow B @ Crack_Mag100x

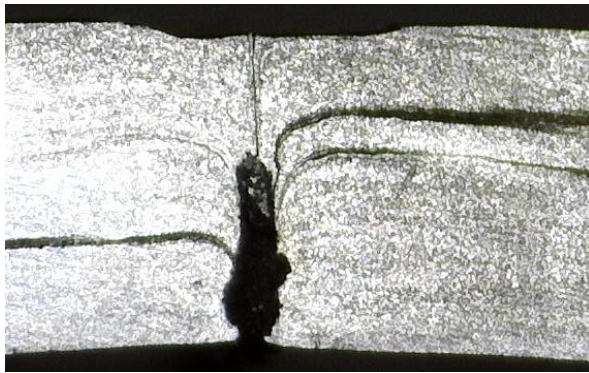
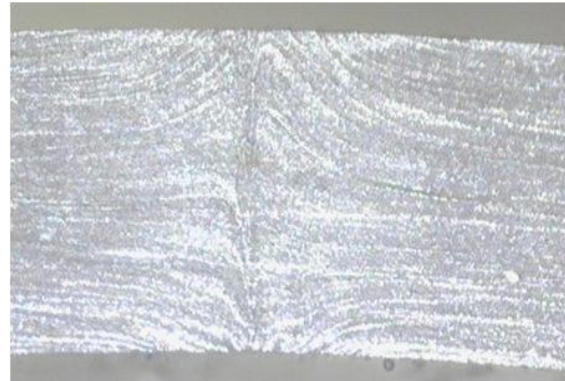
Weld flow C @ Away from Crack_Mag80x

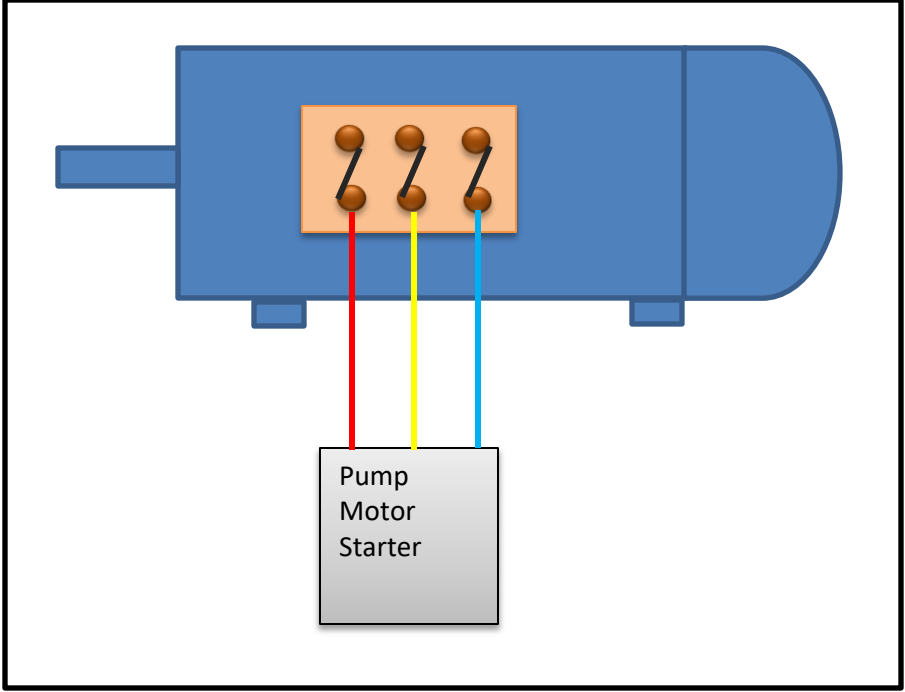
Before

WHY – 1	WHY- 2	WHY -3	WHY-4	Why-5
Raw water pump failure.	Motor Terminal block overheat and burnt.	Over a period of time.

Motor terminal block – 6 Terminal.

<i>Occurrence Side Action</i>				
Sr. No	Cause	Countermeasure	Target. Date	Status
1	Occurrence	Motor Terminal block design will be changed from 6 terminal to 3 terminal with modification of winding. (Fig shown in next slide)	20/04/2022	
<i>Detection side Action</i>				
1	Detection	ECT threshold changed from 60 % to 50 % to detect less bonding strength.	With immediate effect.	Started.
2	Detection	One complete tube before stoppage will be removed Instead of defective portion of tube.	With immediate effect.	Started.

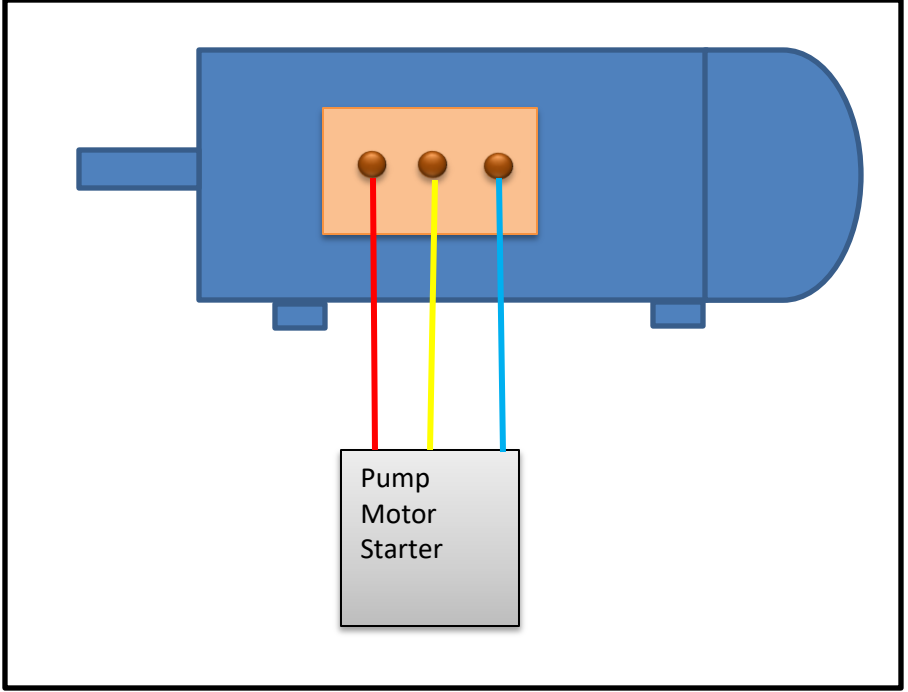
After

Motor Terminal block – 3 Terminal with modification of winding.
