# Problem description

● **Phenomenon:** End Coil Squareness Out of Spec. 1.00 mm Max.

- **Supplier:** Helical Springs
- **Model:** REJ1A
- **Parts name:** Main Spring
- **Part No.:** F2GN125020
- **Date of Occurrence:** 23.03.2023
- **NG Qty:-** 67 nos

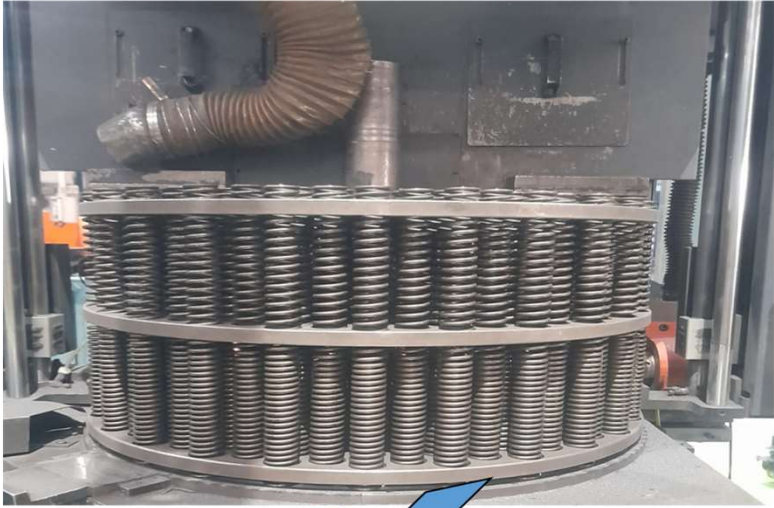
<p>स्प्रिंग प्लेट मे स्ट्रेट बैठा है ये सही है</p>	<p>स्प्रिंग प्लेट मे तेढा हुआ है। ये गलत है</p>	
<p>Prepared by : Nilesh Kapure</p>	<p>Approved by : Mr. Arun Kumar</p>

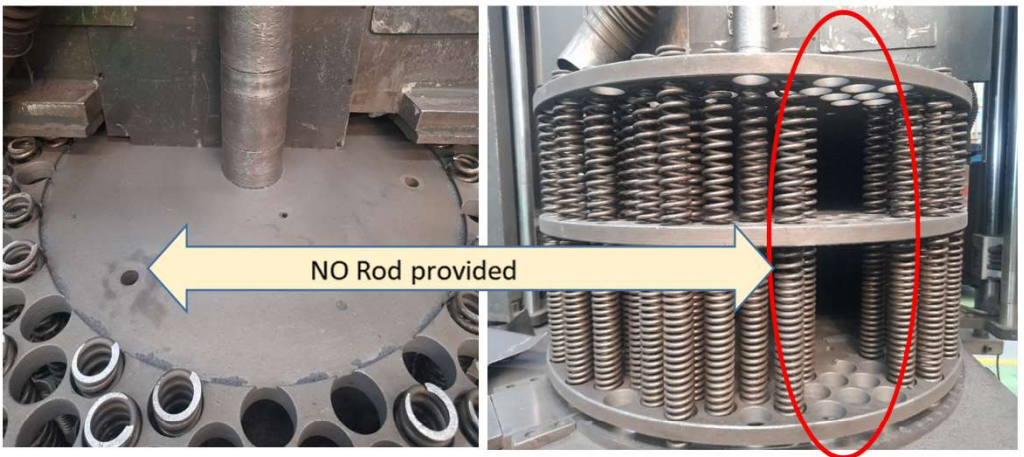
**BEFORE**

WHY - 1	WHY- 2	WHY -3	WHY-4	WHY-5	WHY-6
Occurrence	End Coil Squareness Out of Spec.	Spring not loaded straight in Grinding plate	Grinding plate position not ok	Holes in layer wise Grinding plates not aligned with respect to each other	Alignment of holes of three plates checked with insertion of spring	No robust method to check the alignment of holes of three plates
Outflow	End Coil Squareness Out of Spec.	Not arrested in inspection	Inspection done on sampling basis	No 100% inspection defined	--	--

**NO ROD PROVIDED FOR ALLIGNMENT OF GRINDING PLATES**
