**30x28-Sapthagiri Engineering-Crack sample analysis and action plan.
Complaint received on 28/03/23 through ETL Sanand (Spinning crack)**

Customer :- Saptagiri Engineering.

Complaint :- Weld Crack.

Size :- 30x28.

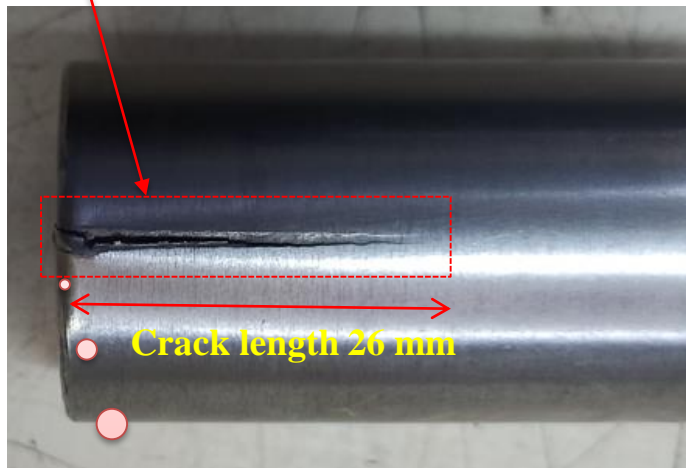
OD	29.97/30.04 mm
ID	27.97/28.03 mm

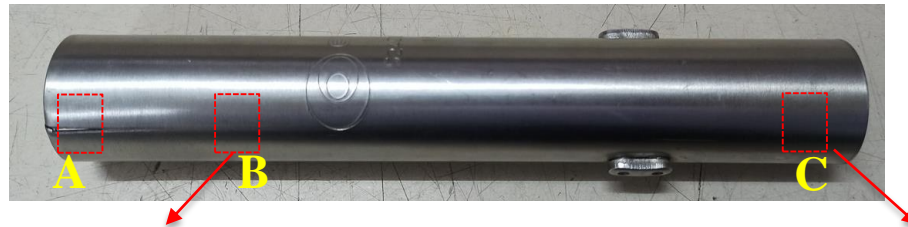
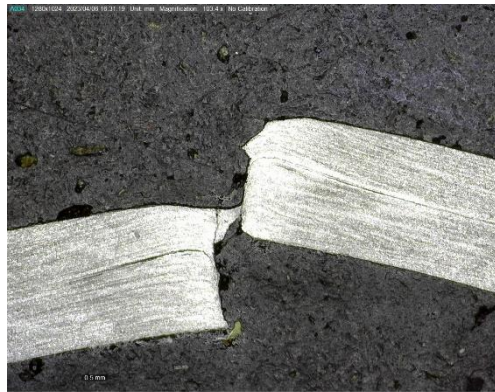
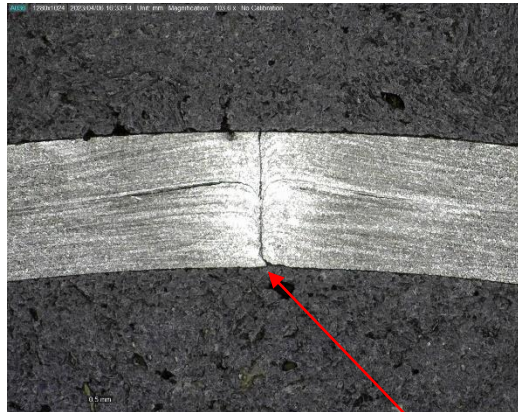
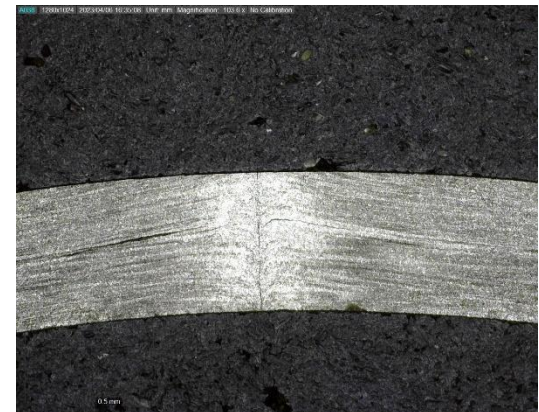
Weld flow analysis

Observations:-

1. Crack observed on the weld line
2. Crack started from ID side
3. Weak weld line and parallel weld flow A and B location

WHY – 1	WHY- 2	WHY -3	WHY-4	Why-5
Weld Crack.	Cold weld (Weak weld bond line)	Improper squeezing during welding at localized area	Less heat (Could be set up or stoppage tube)	Stoppages are more due to surface defect correction.

Sr. No	Cause	Countermeasure	Target. Date	Status
1	Improper squeezing during welding at localized area (Stoppages are more due to surface defect correction.)	<p>Long term action -We are procuring the New Imported roll set(Japan- Sanyo Seiki, Korean), Proposal already raised. It will take 3 months' time.</p> <p>Short term actions - In the meantime we are making arrangement to make New roll set for forming and fin pass section with similar design with domestic supplier.</p> <p>To eliminate the stoppages due to od deburring related issues , we have installed single point tool with double post. (Kaizen sheet attached)</p>	<p>1) July-23 2) May 23 first week. 3) Completed on 04 th April -23</p>	Short term actions completed.

1	Detection	As per Stoppage Matrix one extra tube will be removed.	Implemented by Jan-23	Started.
2		On line ECT at TM 2 Planned.	15 th July-23	Capex approved.
3		To Increase the ECT Sensitivity ECT Actual coil ID will be reduced from 38 to 35 MM.	June -23	PR and PO raised.
		Installation of thermal mapping system will be explored.		It is under discussion.
4				
5
