JZ/JH RR Complaint- Flash on lens edge Date- 06.05.2023

UNO MINDA

Action Details

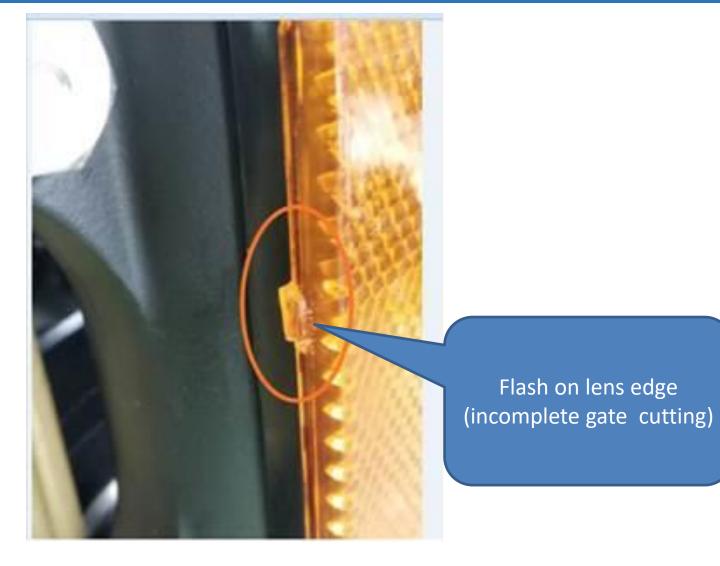
SN	Defect Phenom ena	Root Cause	Corrective / Restoring action (4M1T conditions)	Preventive & Detection actions	Tgt Date	Status	Sustenance action	System action
1	Flash on lens edge	the part & cutter while de-gating. Why 3 - Gap due curved shape cutter used (inconsistency in gate cutting).	 WI made & displayed at work station to use Plier plastic cutter nipper 152 mm-6 STANLEY cutter. Q-Alert displayed & awareness training given to operators 	 Check point started at final stage by hand feeling at gate cutting area to ensure no flash . Check point added during PDI inspection 	09.05.23		Check point during in process inspection	FPA updated

Corrective Action					
Before	After				
	<image/>				
Curved shape cutter used for lens gate cutting, observed inconsistency in lens gate cutting (man to man variation)	Plier nipper 152 mm-6 STANLEY cutter provided for easy lens gate cutting to operator
