## Countermeasure: - Machining stage

DRILL MACHINE :- SE/CNC/02 Date: 01/06/2023

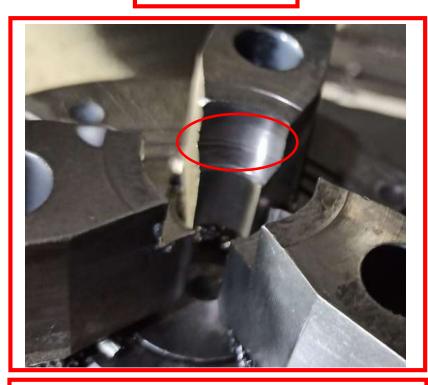
Burr cleaning done thru air pressure, improper cleaning because there is no under cut in clamping chuck jaw, burr, chip not removed from Chuck jaw properly.
