Analysis of Piston Seal ID Cut B2RU004020

Customer: Endurance Tech. Ltd.

Submitted By: Fukoku India Pvt. Ltd.

Date: 05/06/2023

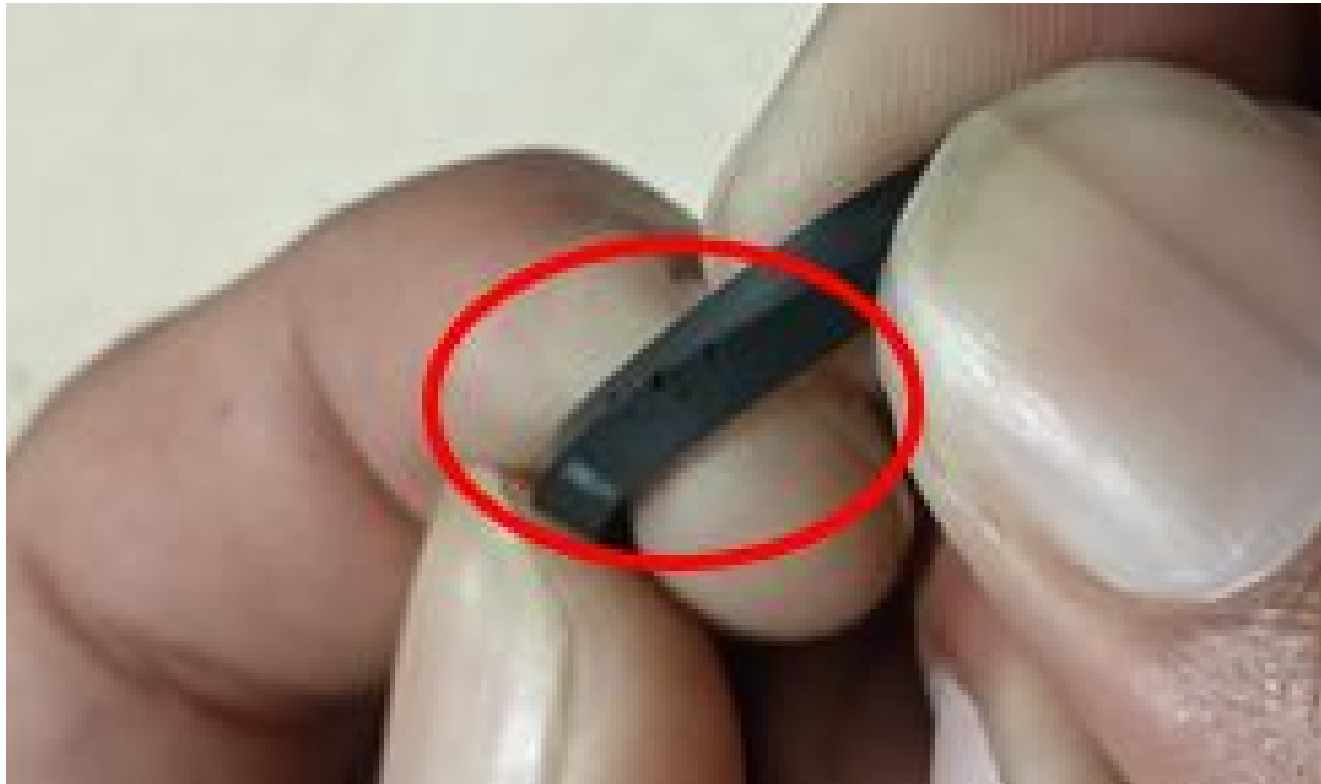
Actual Ng Part

In actual Ng part ID cut observed due to which leakage in Caliper Assembly

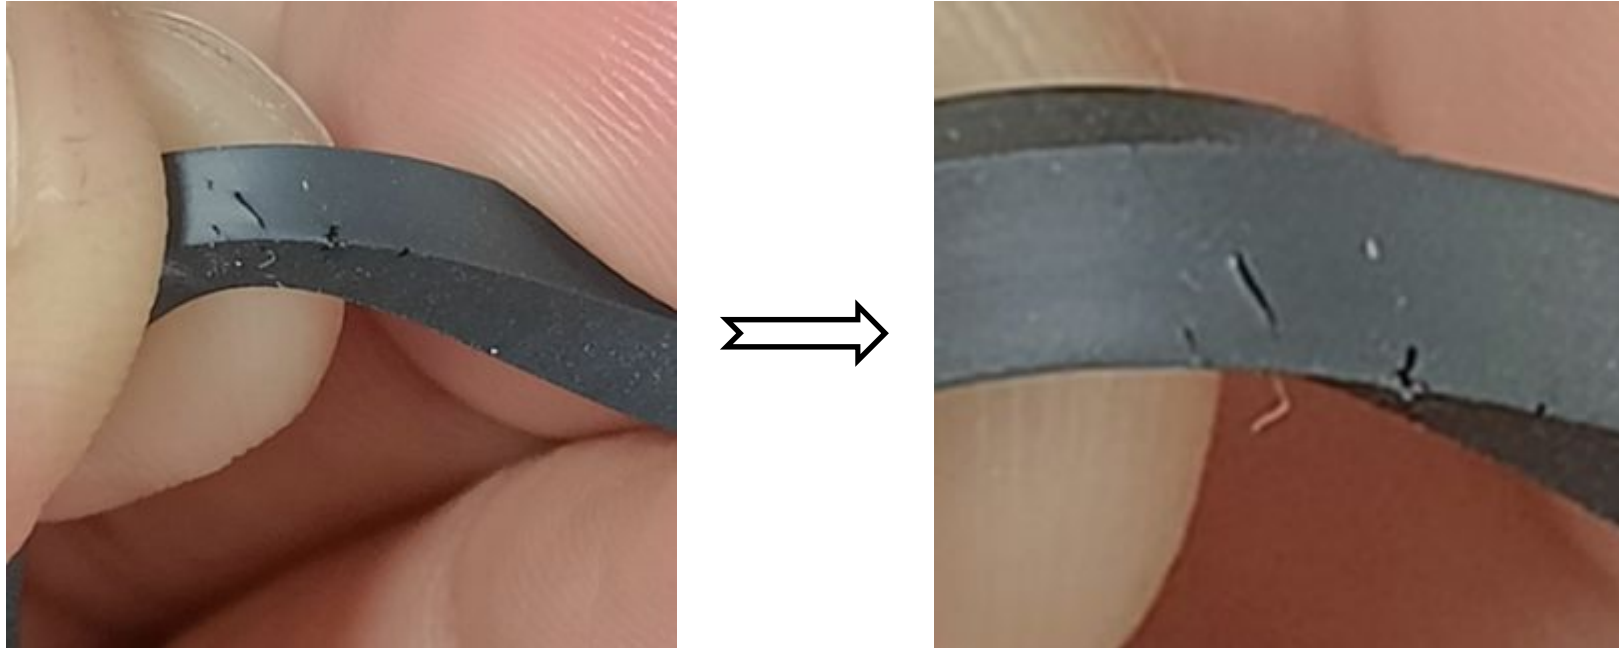
After physical part verification it is observed that Cut is in only one side of the seal at ID and there is side cut mark is also observed

ID Specification :- 28.240~28.660	Actual Observation : - 28.516-28.573	→ OK
Cut Width : - 3.050~3.300	Actual Observation : - 3.214-3.222	→ OK
Thickness Spec. : - 2.860~2.960	Actual Observation : - 2.891 – 2.941	→ OK

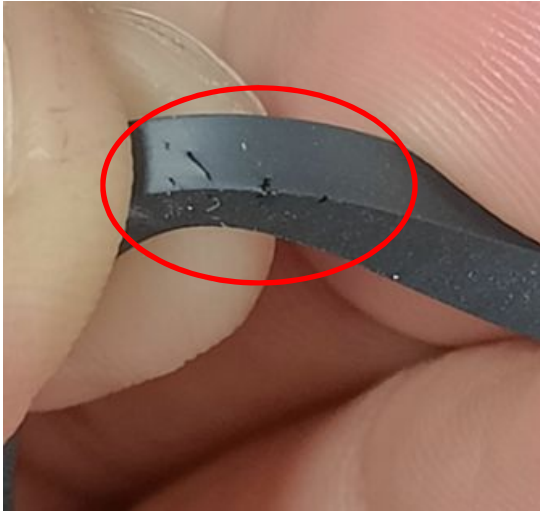
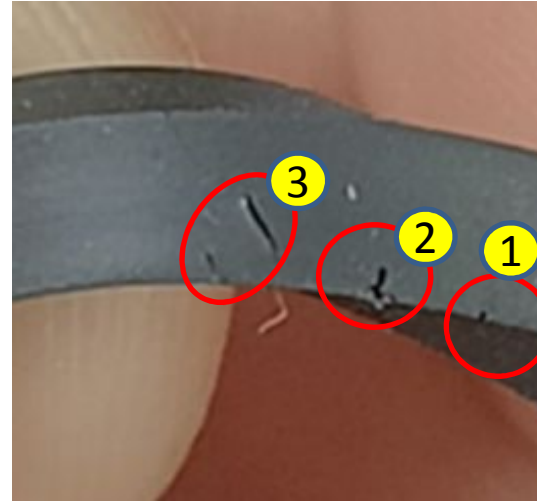
Final Analysis and Conclusion

1. After verification of our different process we observed that, in our past we don't have such past trouble history for this type of defect.
2. There is no any possibility of ID corner cut in our any process. (Pt. 1 & 2)
3. We observed there is running cut mark (one is deep and other is small at Pt.3) on the side wall of piston seal which can not be occurred in our process as the slicing is done at cutting process where the marked area doesn't come in to the picture of process.
4. While inspecting the Cut area we feel that the cuts are generated by sharp external object.
5. By the measurement result on said part , all the fit / Function parameters are within Spec., so there could be some other reasons for the leakage, which is beyond our scope of investigation.

So, we feel that such defect could have generated while removing the seal from Seal Groove as it is difficult to remove by fingers and so ,is not a cause of assy. leakage.
