# **Root Cause Analysis**

Occur / Outf.	Problem	Why-1	Why-2	Why-3	Why-4		
Occurrence	Trimming part stucked in tool ,chance of claw width over	Sometime parts get stuck up in Die after trimming and does not fly even puff of air. Operator keep running the machine continue, then core plate lug pressed by punch and claw width size become over.	There is narrow space for the trimming tool to come off when the part is stuck	No provision in tool to avoid such type issue	Claw width oversize possibility not considered as an failure mode in PFMEA during trimming		
Outflow	Checking method not sufficient to detect claw width over size on one claw at trimming & PDI	Claw width checked by vernier caliper ,during set-up, houlry & PDI, which does not ensure of whole lot /parts	Claw width oversized (One claw) possibility not considered while defined in control plan	No criteria for defining the inspection method in control plan	Procedure not available for control plan & inspection standard

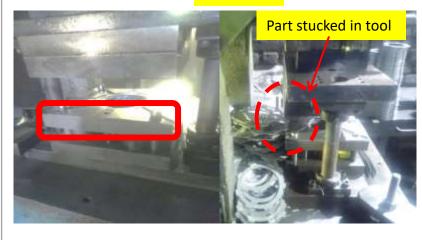
Part stucked in tool due to there is 0.50 mm draft in tool chance of claw width over size

Part ejection system to be made in trimming tool to avoid stuck issue. Done 2.11.2023

3.0 mm slot provided in tool to avoid claw width over size ,No chance of oversize
