Defect Analysis Report

W/O- 967/0 (K19)

Part Name: Plate Clutch

Part Number: C2JT042020

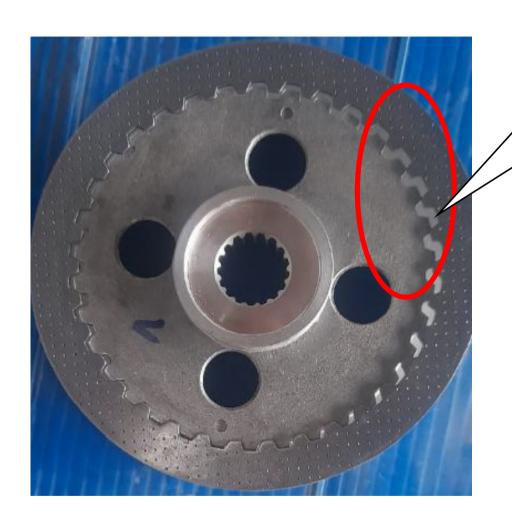
Issue detail: Teeth ID not OK- Fitment Issue

Fitment issue

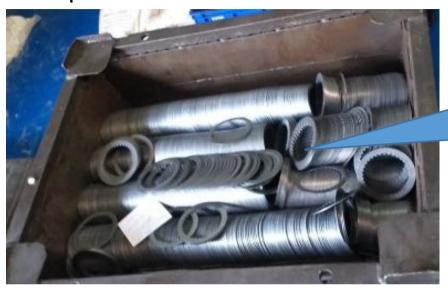
Inter plant Material movement in bin

Possibility of material bend during transportation → After getting bend same material getting straight in next straightening operation but ovality will generate at ID and OD

Action plan:- Material will be stack in bin and loose material should not be kept over.

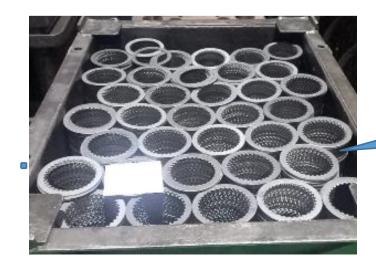
Possibility of material bend during transportation→ Eliminated

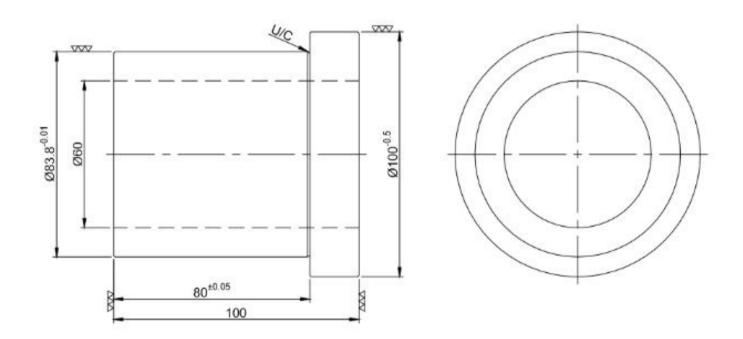
NO control given in control plan for bend component

New type gauge design made and 100 % inspection started in next lot production
