Non conformity details:

Bracket ABS MTG Not Rest on ABS Modulator.

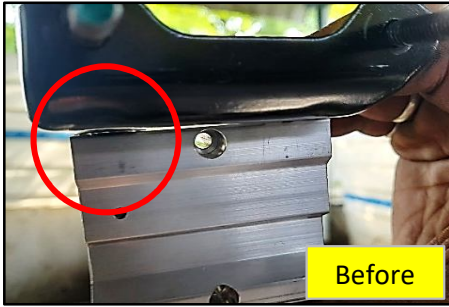
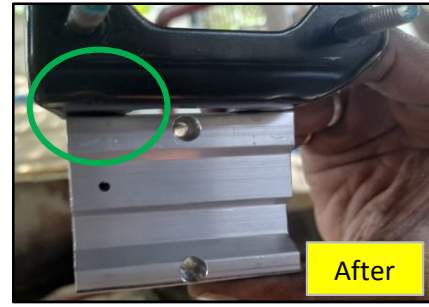
Bracket ABS MTG Flattness Not OK

New Flattning Tool for Bracket ABS MTG implemented.
