AURANGABAD PRESSINGS

Corrective / Preventive Action

Part Name: Bracket ABS MTG

Part No: B2SU01102 O

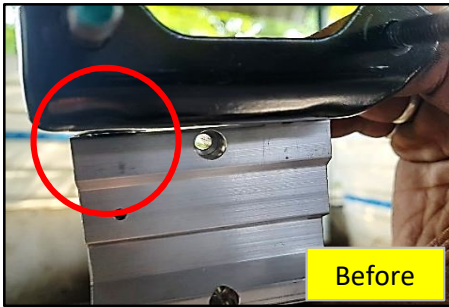
Before

Bracket ABS MTG Not Rest on ABS Modulator.

Bracket ABS MTG Flattness Not OK
