## **Before & After**

**Component** :- Fork Bolt

**Stage** : **Final inspection**

**Date of Implementation:** 22.01.2024

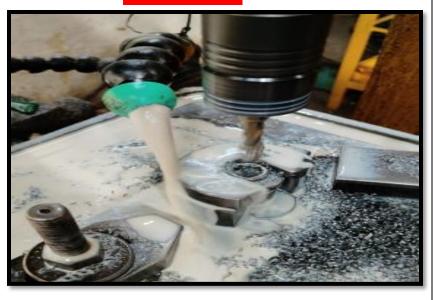
## **BEFORE**

coolant direction is wrong..
