QSR Issues – Corrective actions

Part name & Part no. K2 – Caliper Body

Model- Customer complaint :Casting Blow Hole

Physical Phenomenon : Casting Blow Hole

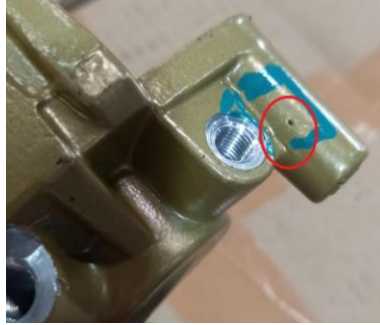
Blow Hole observed at casting surface

Part Name	Model	Vendor	Defect	Actions	T. Date	Status
			<p>Customer complaint – Blow Hole observed at casting surface</p> <p>Physical Phenomenon – Blow Hole observed at casting surface.</p> <p>Why 1; Blow Hole observed at casting surface</p> <p>Why 2: Gas get entrapped</p> <p>Why 3: Gas not able to escape through air vent</p> <p>Why 4: Coating deposited at air vent pin.</p> <p>Why 5: Air vent block</p> <p>Root: Vent pin block due to Coating deposited at air vent pin while applying dye coat</p>	<p>Containment Action :-</p> <ol style="list-style-type: none"> .ETL End – Qty rejected by ETL <p>Inspection side action Supplier End:-</p> <ol style="list-style-type: none"> Q-alert Displayed. Master sample provided ETL Visual standard displayed at final inspection and Master sample provided <p>Inspection side action ETL End:-</p> <ol style="list-style-type: none"> Q Alert displayed <p>Cause Side Action :-</p> <ol style="list-style-type: none"> Vent plug should be clean everyday once On job training given to the operator 100% final inspection should done 		<p>Completed</p> <p>Completed</p> <p>Completed</p> <p>Completed</p> <p>Completed</p> <p>Completed</p> <p>Completed</p> <p>Completed</p>

HORIZONTAL DEPLOYMENT : K11 caliper body

SUSTENANCE (PREVENTIVE) ACTIONS: First Piece inspection

SYSTEM ACTIONS :-In process Inspection, Process Audit & Product Audit

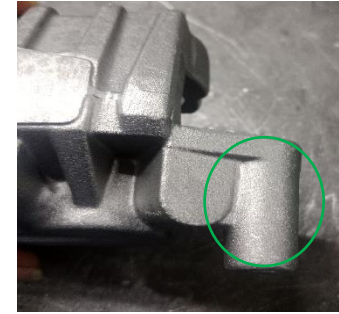
After

Free from blow hole at casting surface

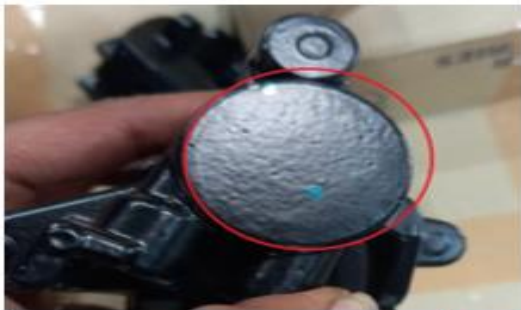
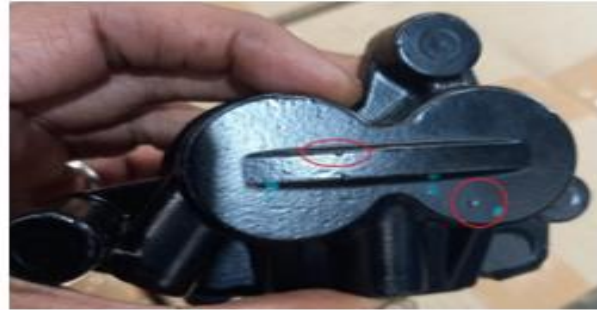
Defect Casting

Date of Complaint : 07.08.2023
Customer Complaint : Blow Hole
Classification of Complaint : CUSTOMER COMPLIANT

1. Check 100 % Final inspection

- Don't Despatch the casting with **Blow Hole in AsCast.**
- Should be check free from **Dent & Damage issue.**
- Should be check free from **excess flash.**
- Provide **dot mark on the top of the face area .**

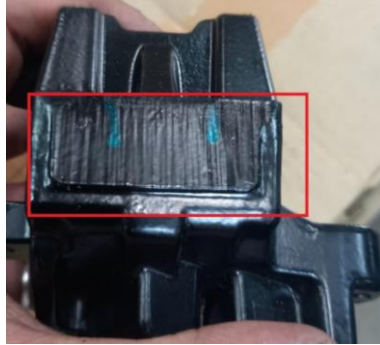
Before

Undercut found at riser area

Part Name	Model	Vendor	Defect	Actions	T. Date	Status
			<p>Customer complaint – Undercut observed at riser area</p> <p>Physical Phenomenon – Undercut observed at riser area</p> <p>Why 1: Undercut observed</p> <p>Why 2: Unskilled manpower used for riser cutting</p> <p>Why 3: Training were not given to the operator</p> <p>Root: Casting not arranged in dedicated pallet</p>	<p>Containment Action :-</p> <ol style="list-style-type: none"> .ETL End – Qty rejected by ETL <p>Inspection side action Supplier End:-</p> <ol style="list-style-type: none"> Identification mark “Dot” Provided at particular area. Quality alert Displayed. ETL Visual standard displayed at final inspection and Master sample provided <p>Inspection side action ETL End:-</p> <ol style="list-style-type: none"> Q Alert displayed <p>Cause Side Action :-</p> <ol style="list-style-type: none"> On job training given to the operator 100% final inspection should done carried out as per ETL standard 		<p>Completed</p> <p>Completed</p> <p>Completed</p> <p>Completed</p> <p>Completed</p> <p>Completed</p> <p>Completed</p>

HORIZONTAL DEPLOYMENT : K11 caliper body

SUSTENANCE (PREVENTIVE) ACTIONS: Separate Pallet has to provide

SYSTEM ACTIONS :-In process Inspection, Process Audit & Product Audit

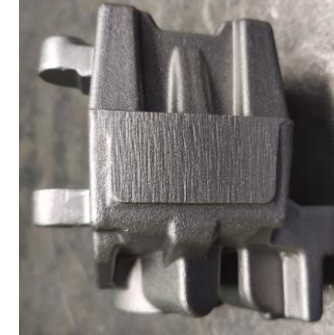
After

Free from damage at casting surface

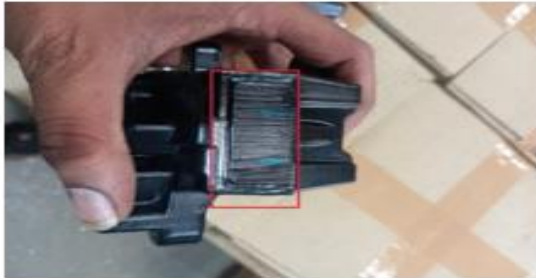
Defect Casting

Date of Complaint : 07.08.2023
Customer Complaint : Undercut issue
Classification of Complaint : CUSTOMER COMPLIANT

1. Check 100 % Final inspection

- Don't Despatch the casting with Undercut issue in AsCast.
- Should be check free from Dent & Damage issue.
- Should be check free from excess flash.
- Provide dot mark on the top of the face area .
