<b>ENDURANCE</b> Complete Solutions Endurance Group		<b>Corrective Action Report (Supplier)</b>				Doc No. : FT-QA- 43 A Rev. No. : 00 Rev. Date : 04.08.2021 Page No. : 01 of 02				
NC No.		Part No. & Rev. No.	520PL043020/B	ETL Division	SUSPENSION					
NC Date	30.05.2024	Part Name	WASHER DF-01	ETL Plant	NARSAPURA					
NC Submission Date		Supplier Name & Code	SAPTAGIRI INDUSTRIES(100165)							
<b>1. Problem Description (To be filled by ETL)</b>										
Defect Description		THICKNESS O/S			Defect Photo / Sketch

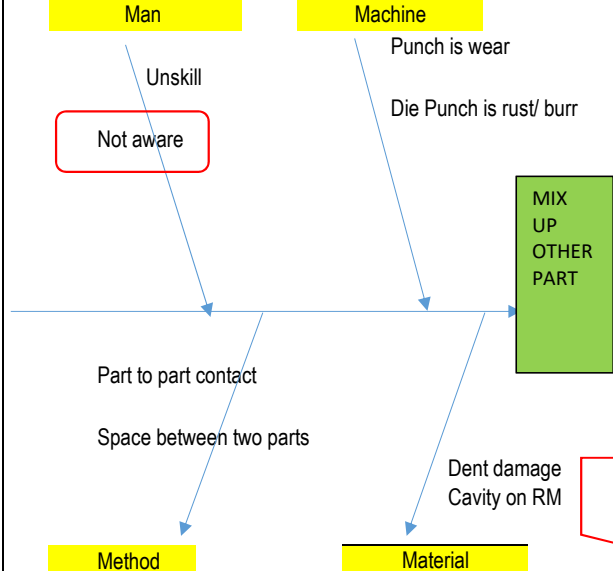
#	Possible Cause	Fact Verification	Jud					
			Punch is wear	Not	●					
			Die Punch is rust/ burr	Not	●					
			Dent damage Cavity on Material	No chance all portion of Die Is found OK	●					
			Part to part contact	No contact	●					
			Space between two parts	No metal contact	●					
			Unskill	Skill man	●					
			Not aware	Awareness is less	▲					
<b>6. Inspection Method Analysis (Current) (√)</b>										
Inspection Method	Pokayoke	Gauge	Instrument	Sp. Gauge	Other	Visual

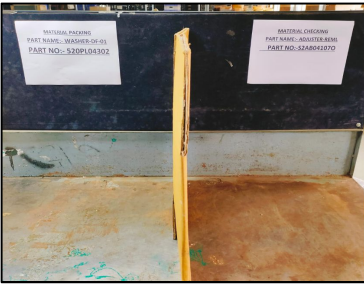
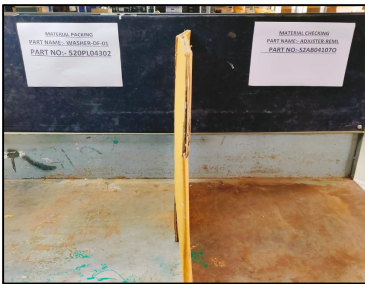
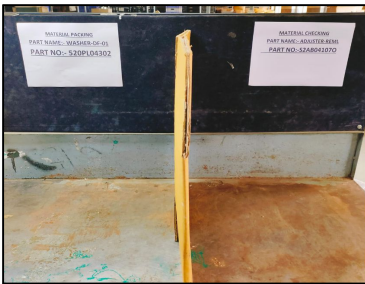
10. Evidence of Countermeasure						
Occurrence	Before	After		Outflow	Before	After

7. Root Cause Analysis						
Occurrence	Why 1	Why 2	Why 3	Why 4	Why 5	
		Material Thickness os More	Wrong size part	Mix other part		
Root Cause (Occurrence)		Mix other part

Endurance Group		<b>Corrective Action Report (Supplier)</b>		Doc No. : FT-QA- 43 A	Rev. No. : 00	
				Rev. Date : 04.08.2021	Page No. : 02 of 02	
Outflow	Why 1	Why 2	Why 3	Why 4	Why 5	
	Material Thickness os More	Inpection method is visual	for visualisation sufficient Awareness required	At a time multi model packed		
Root Cause (Outflow)		At a time multi model packed

8. Countermeasure ( Occurrence , Outflow & System side Actions ) Both, Long term and short actions to be mentioned						
#	Countermeasure Details			Resp.	Tgt Date	Status
Occurrence	Get separate the tables of Modelwise			Mr. Solankhe	21.06.2024	G
Outflow	At a time only One part Model to be Packed			Mr. Pradip	24.06.2024	G

Get partition,				
11. Horizontal Deployment (√)						
Horizontal Deployment Required		Yes	√	No	Target Date	01.06.2024
Applicable Machine / Model / Plant
