Casting Crack Issue of KOLA

- **Phenomenon:** Casting Crack

- **Model-** KOLA drum LH
- **Parts name-** Outer Tube
- **Qty NG-** 118 No Each

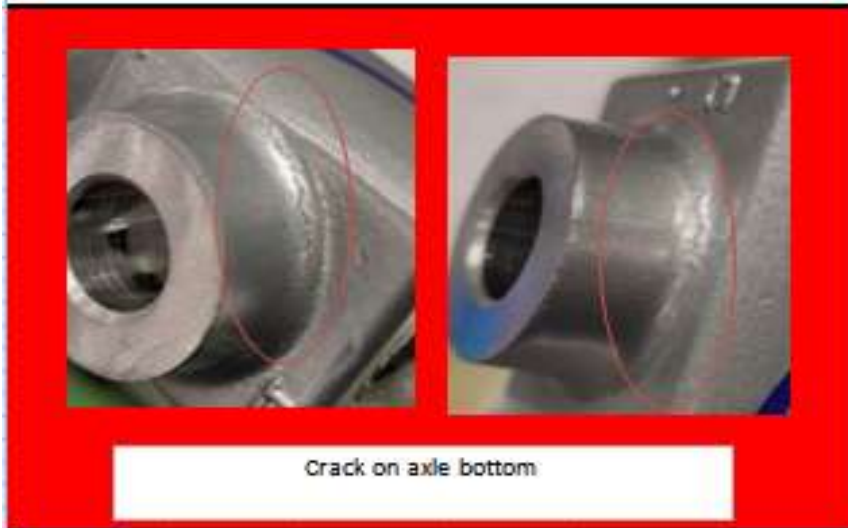
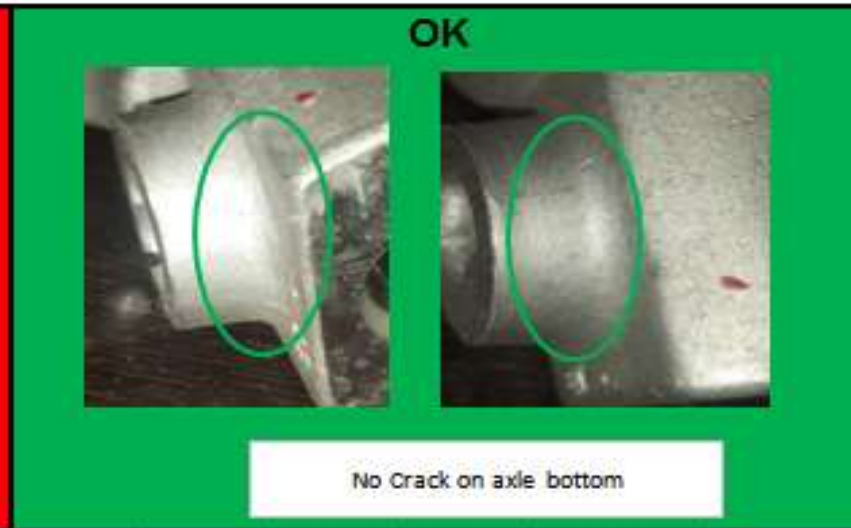
Problem	Crack on axle bottom	Occ.	<i>New</i>
Cust.	Customer Complaint	OPL NO	DC/OPL-21
Part Name	K0LA	Date	15.06.2024
<input type="checkbox"/> In house Problem	<input checked="" type="checkbox"/> Customer complaint	<input type="checkbox"/> Improvement Idea

K0LA drum Crack on axle bottom

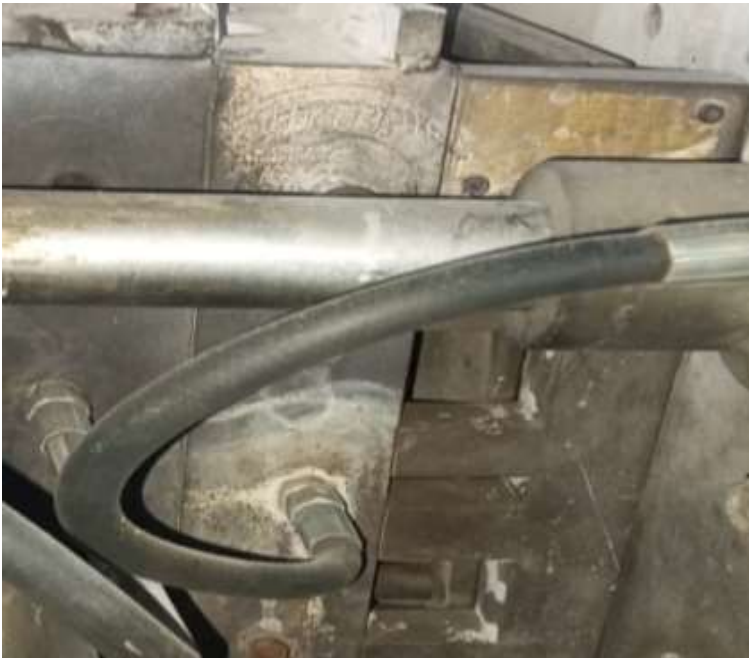
BEFORE

- **Conclusion:** The operator incorrectly placed the chilling pipe in the centre of the die, so the bottom side of the part did not cool properly, resulting in a crack.

Chilling pipe inserted to **middle**
side

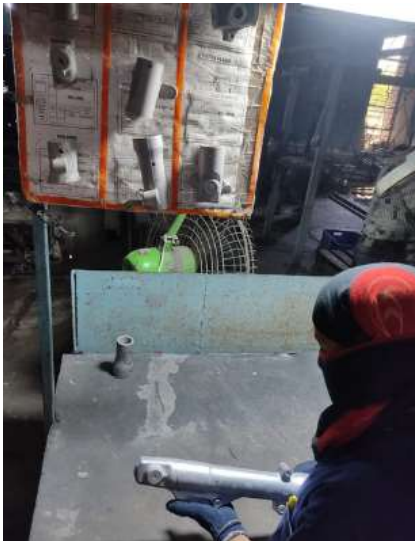
BEFORE

Inspection done by Visual as Per limit sample

- Inspection done by Visual as Per limit sample but chances of Minor defect skip

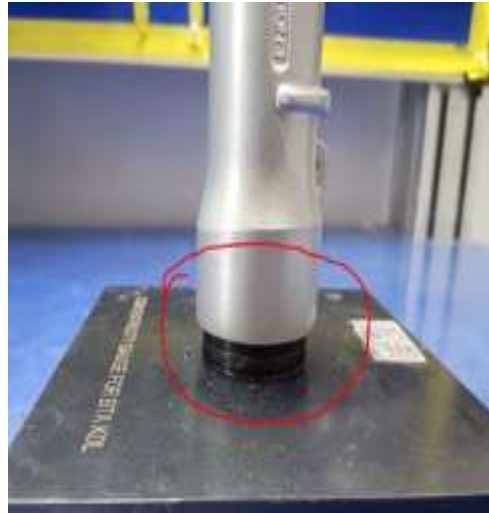
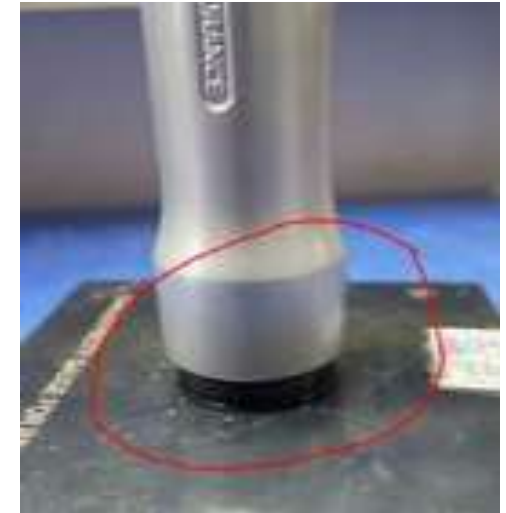
- **Phenomenon:** concentricity up to 0.3
- **Supplier-** Endurance Technologies Ltd. Narsapur
- **Model-** KOLA DISC / DRUM LH RH
- **Parts name-** Outer tube
- **Qty NG-** 1740 No Each

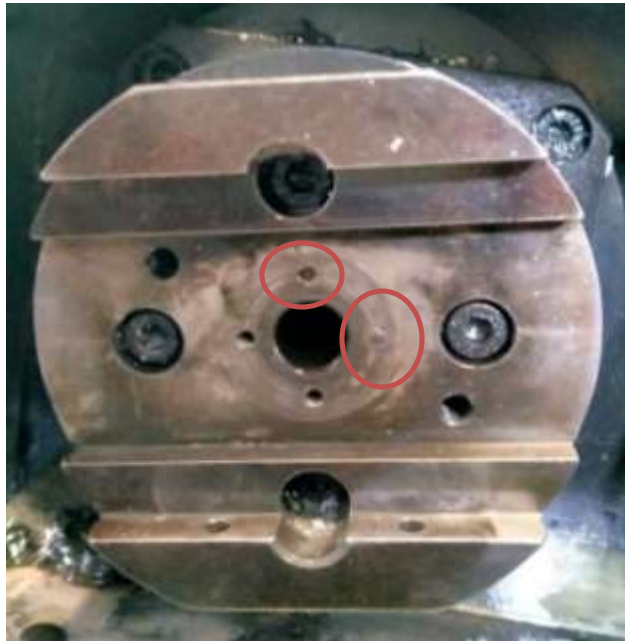
BEFORE

WHY-1	WHY-2	WHY-3	WHY-4
Occurrence Side	Concentricity found up to 0.3	BTA-End hole guide locator fitment 2 of the 4 screws were broken.	End hole guide pin lock not properly.	guide pin run out increase up to 0.2
Detection side	In process inspection checking frequency in 2 part in one shift.	Unskilled operator & Inspector

**End hole guide pin locator 2
screw broken**

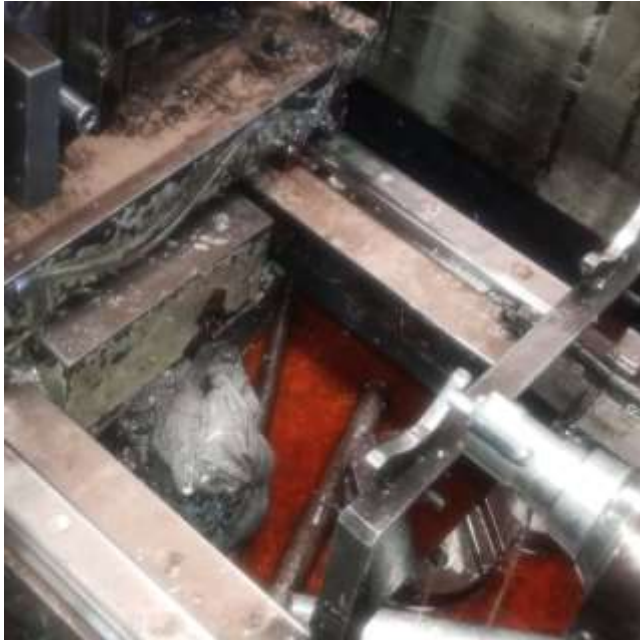
BEFORE

**End hole pin locator in checked
for dial stand pin run out 0.2**
