## **ACTION EVIDENCIES --- Detection**

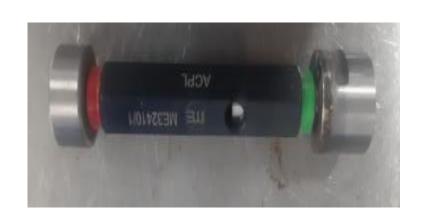
PPG observed in Wearout Condition

New Carbide PPG Procurement Done
