## Countermeasure

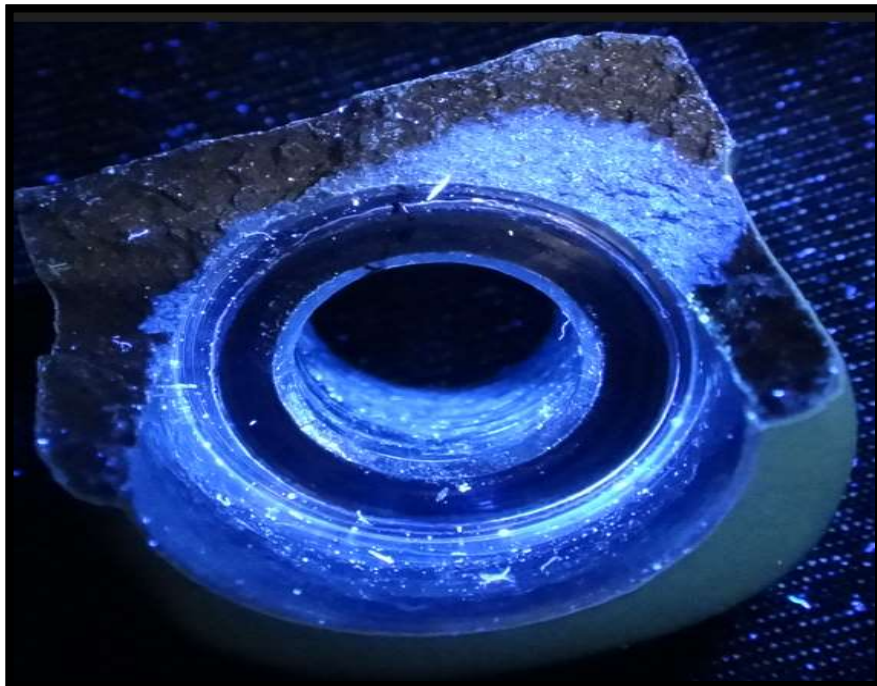
**Machining oil layer was found to be present in some thread area.**
