TUBE PRODUCTS OF INDIA SHIRWAL

27.50X25.50-Saptagiri-Crack sample analysis

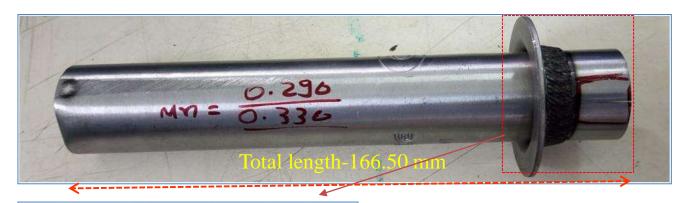
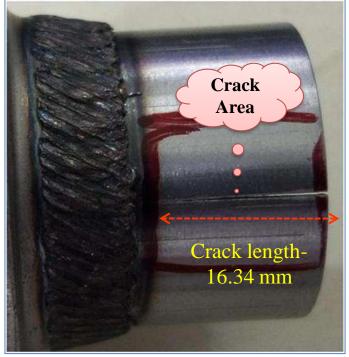
Sample Details

Batch Code: 02-11-22 T

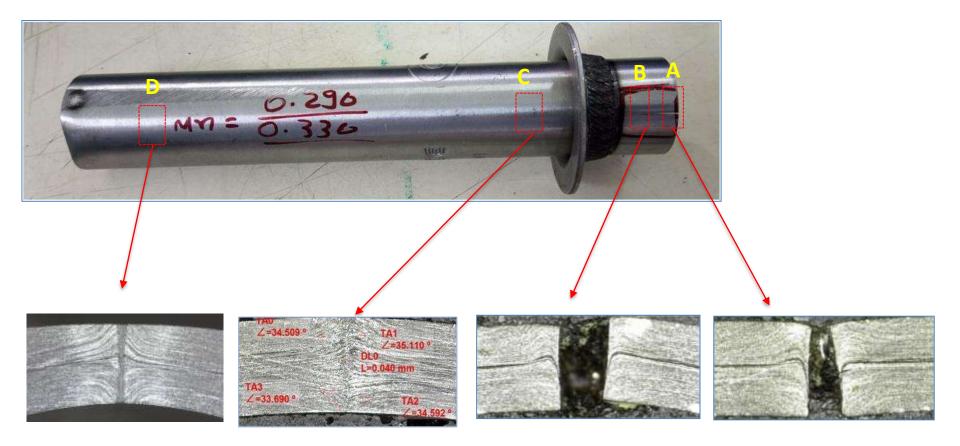
Weld flow analysis

Observations:-

- 1) Crack observed on the weld line
- 2) Sample C location butting observed skewed.
