Tube Products of India

Endurance 30.25x24x555.5 - Updates

Complaint Details

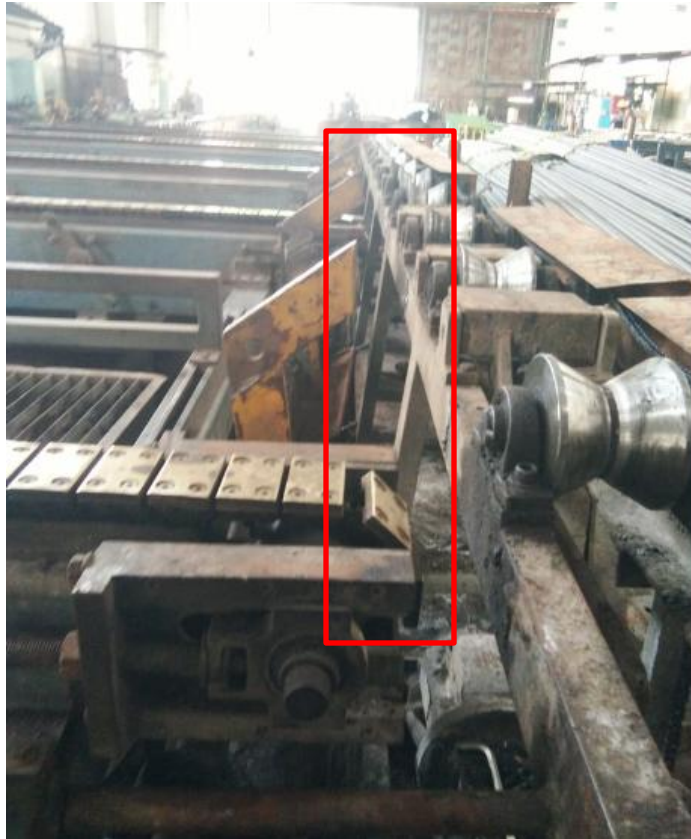
Corrective Action –Evidences

Separate bucket provided at tempering stage to quarantine the NG tubes

- 1. Separate bucket provided at tempering stage to quarantine the NG tubes – Completed 29-03-2023**
- 2. Auto paint spray system introduced during tube struck up in tempering line more than 3 sec -Completed 29-03-2023**
- 3. Interlocking of Tube struck up (more than 3 sec) and Tempering coil power off is provided - Completed -30-03-2023**
- 4. Hardness verification point added at tempering stage for each job order– implemented form 27-03-2023**

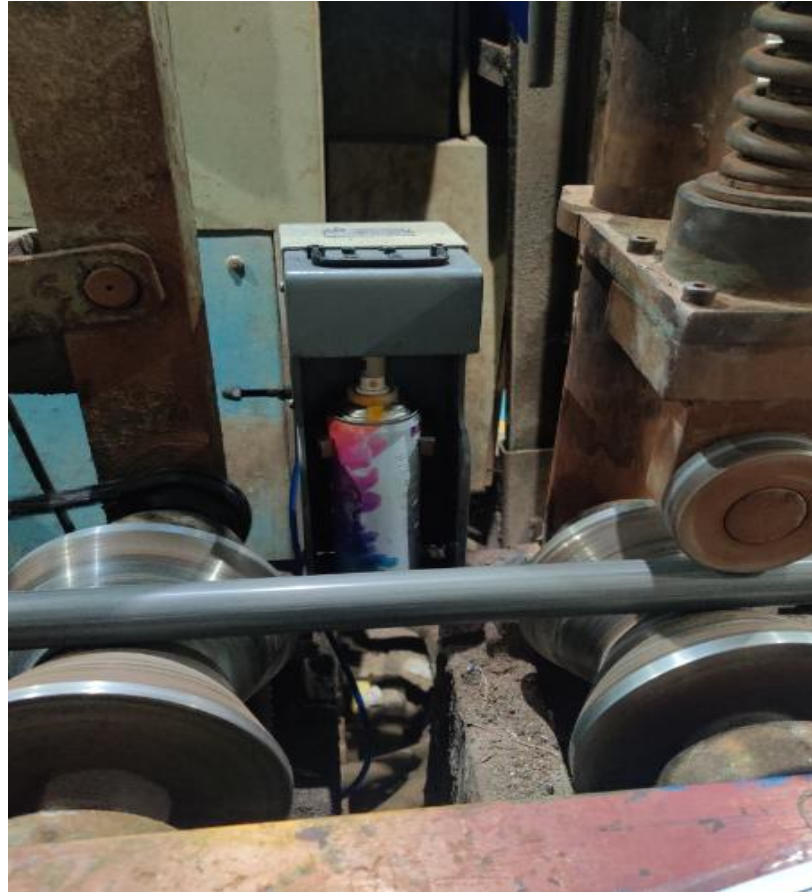
Corrective Action –Evidences

Auto paint spray system introduced for tube struck up more than 3sec

1. If tube struck up >3 sec heating will stop
2. Once the red hot tube moved to NG bucket then the loading bucket kicker will work
3. Not applicable because no off line unloading
4. Spray system introduced.
