GPH Defects & Action Plan By M/S Sanjeev Auto

- Prepared By:- Mr. Dhananjay Nilangekar
- Reviewed By:- Mr. Vijaykumar Wankhede

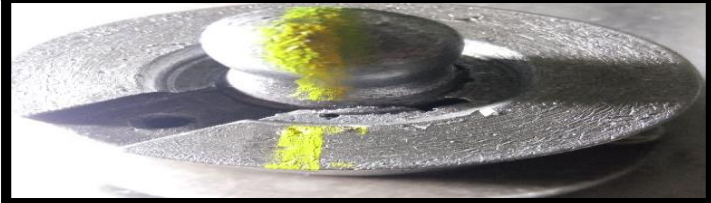
Yellow Marking on Locator
2	Locate The Part in such a way that Parts Milling slot should match with Yellow Marking

SOP Bush Pressing Operation			
Sr No	What To do	How To Do	Check Point
1	Confirm the yellow marking is available On Locator

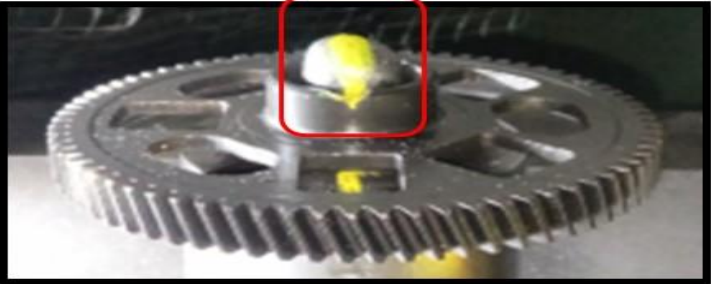
Yellow marking Should Match with Milling slot
3	Locate the bush On Part in such a way that bush Half cut should match with Yellow marking. (Yellow Marking on Fixture should be visible through Bush cut as shown in Image.)

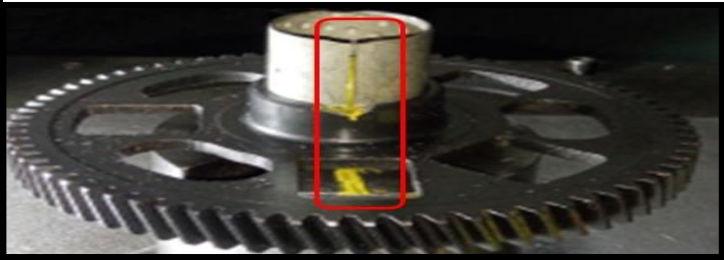
Yellow marking should match with milling slot & Bush centre cut. It should be
4	When bush is pressed by punch, bush fits exactly symmetrical to milling slot .

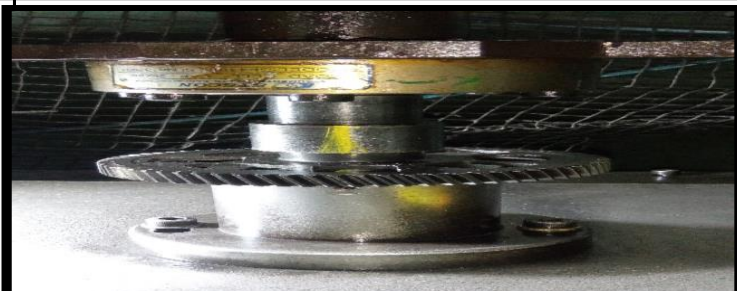
Bush Centre cut & part Milling slot match with each other.
