wrong mtg bolt mix-up observed B2DD002260 and

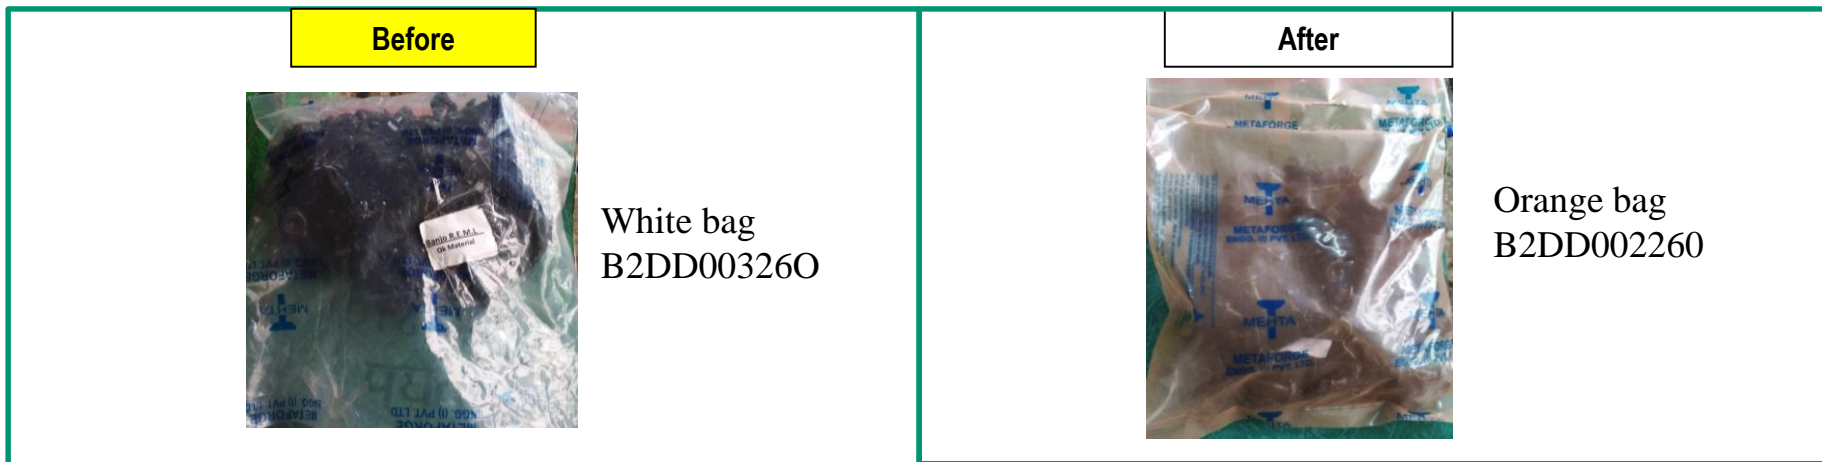
Part Name	Model	Supplier	Defect	Actions	T. Date	Status
B2DD002260 BANJO BOLT	TVS	METAFORGE	<p>Defect Phenomenon – Other part mix up</p> <p>Why 1: 2 type of banjo mix up B2DD002260 & B2DD003260</p> <p>Why 2: During Part surface treatment processing parts got mix up</p> <p>Why 3: Surface treatment processing both parts one another one</p> <p>Root Cause: Surface treatment processing both parts one another one</p>	<p>Containment action: 100% stock inspected at ETL and Pipeline of Metaforge</p> <p>Inspection side action:</p> <ol style="list-style-type: none"> 1. 100% Visual inspection 2. Change Bag color for packing white to orange 3. Change the stickers of bag to identify the parts <p>Cause Side Action: Start alternate surface treatment processing for both banjo bolts</p>	<p>03.09.2022</p> <p>02.09.2022</p> <p>10.09.2022</p> <p>02.09.22</p>	<p>In process</p> <p>Completed</p>
