**30x28-Sapthagiri Engineering-Crack sample analysis and action plan.
Complaint received on 28/03/23 through ETL Sanand (Spinning crack)**

Customer :- Saptagiri Engineering.

Complaint :- Weld Crack.

Size :- 30x28.

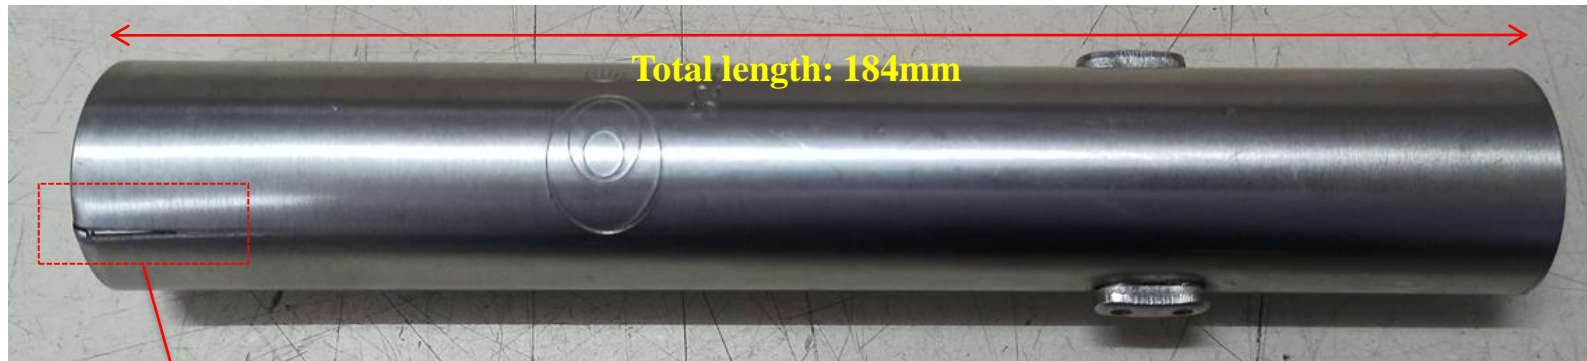
Dimensions

OD	29.97/30.04 mm
ID	27.97/28.03 mm

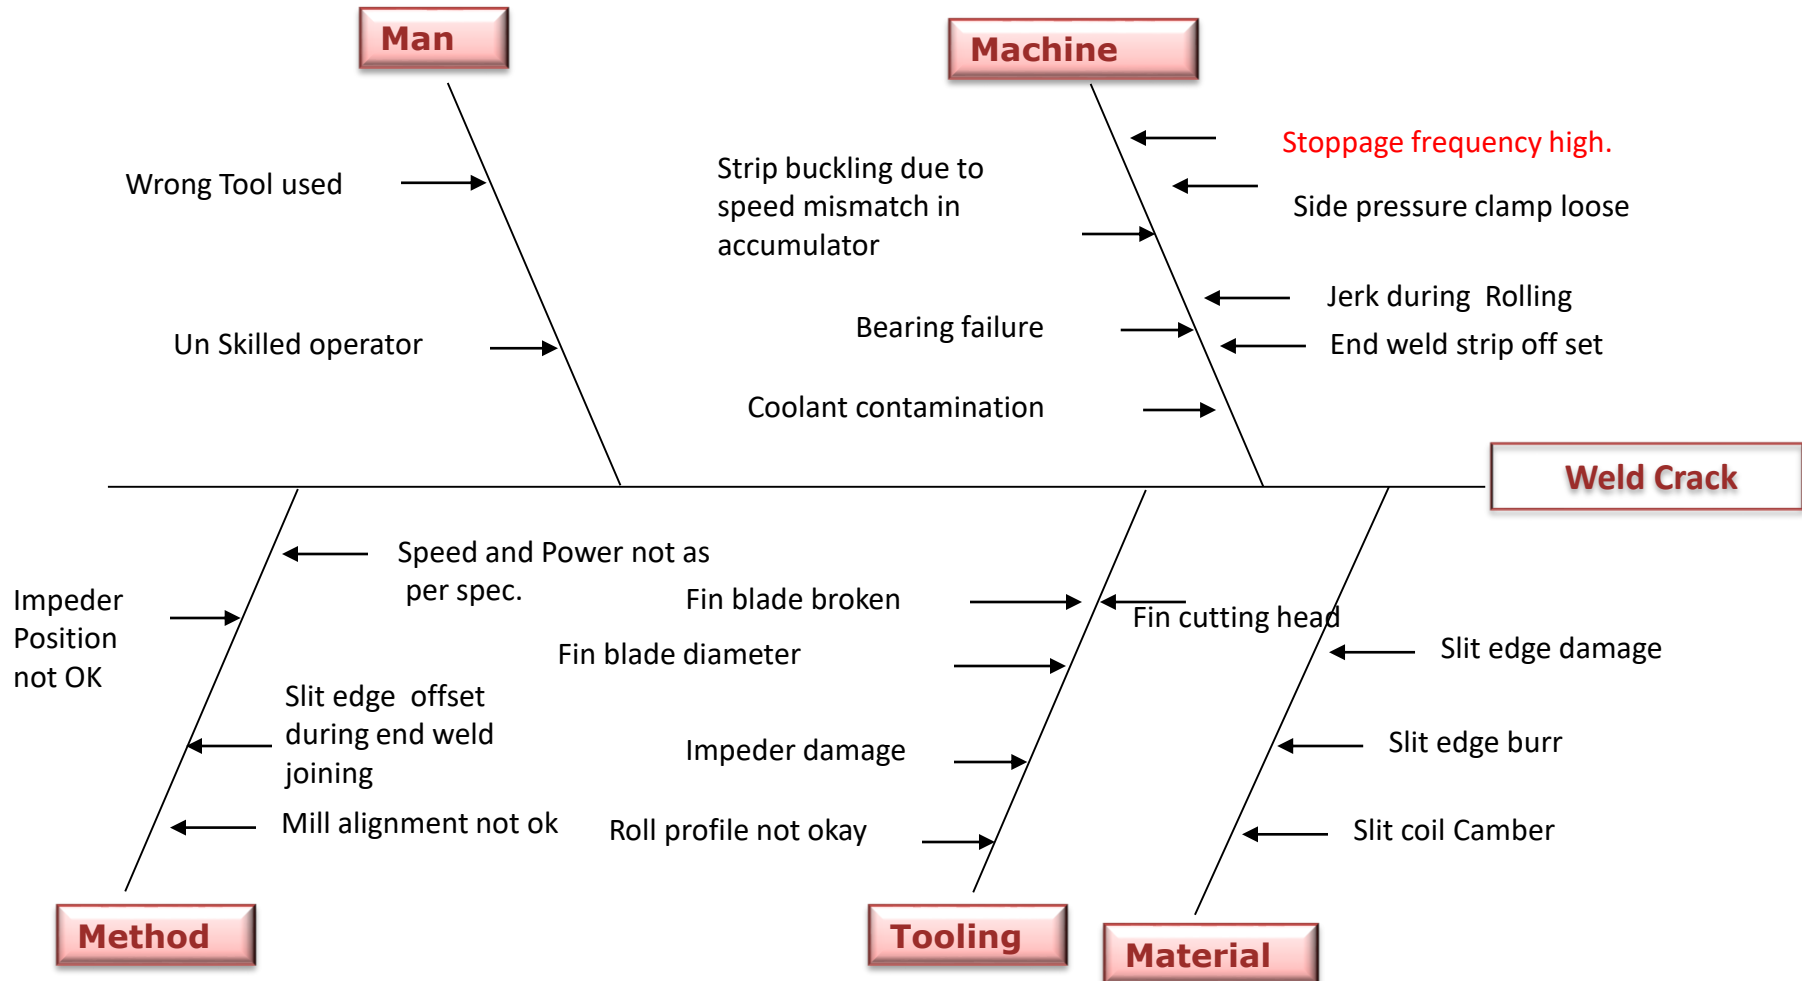
Root Cause Analysis:-

#	4M	PROBABLE CAUSES	FACTS VERIFICATION	Remark
1	MAN	Wrong Tool used	Verified the tool issue process no abnormality observed	OK
		Un Skilled operator	Operators are skilled no new operators on Machine	OK
2	TOOLING	Roll profile not okay	Checked roll profile found ok	OK
		Fin cutting head.	Fin Cutting head checked and observed top roll mounting pin worn out and damage .(Tube mill stoppage was there)	OK
		Impeder damage	Impeder condition was ok	OK
		Fin blade broken	No abnormality observed in Fin blade	OK
		Fin blade diameter	Fin blade diameter is inadequate when end weld is offset	ok
3	MATERIAL	Slit edge damage	Wooden plank on slit storage rack found	OK
		Slit edge burr	No burr observed on slit	OK
		Slit coil thickness variation in initial lap	No Thickness variation in initial lap of slit coil	OK

WHY – 1	WHY- 2	WHY -3	WHY-4	Why-5
Weld Crack.	Cold weld (Weak weld bond line)	Improper squeezing during welding at localized area	Less heat (Could be set up or stoppage tube)	Stoppages are more due to surface defect correction.

Sr. No	Cause	Countermeasure	Target. Date	Status
1	Improper squeezing during welding at localized area (Stoppages are more due to surface defect correction.)	<p>Long term action -We are procuring the New Imported roll set(Japan- Sanyo Seiki, Korean), Proposal already raised. It will take 3 months' time.</p> <p>Short term actions - In the meantime we are making arrangement to make New roll set for forming and fin pass section with similar design with domestic supplier.</p> <p>To eliminate the stoppages due to od deburring related issues , we have installed single point tool with double post. (Kaizen sheet attached)</p>	<p>1) July-23 2) May 23 first week. 3) Completed on 04 th April -23</p>	Short term actions completed.
