Analysis of Piston Seal ID Cut B2RU004020

Customer: Endurance Tech. Ltd.

Submitted By: Fukoku India Pvt. Ltd.

Date: 05/06/2023

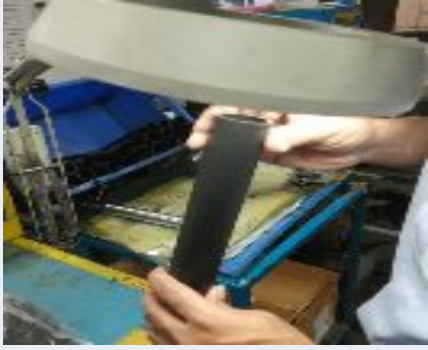
Tube Inspection as per Receiving Inspection Standard	There is no any possibility of abnormal cut on Tube, as this is handled visually	Invalid
3	Storage of Tubes

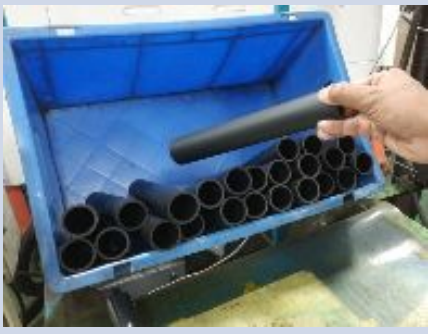
Tubes are stored in defined location as in supplier packing	Storage is done in Bins so no any handling related issue	Invalid

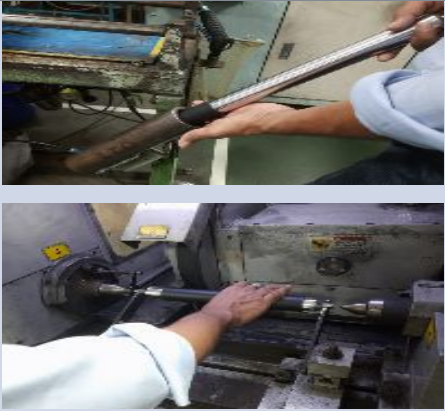
Tube is inserted into the mandrel and grinding is done on the OD of entire tube	Verified the Grinding Mandrel and there is no any abnormality is observed so no possibility of inside edge cut	Invalid
5	Cutting of Tubes 1. Tube insert in Mandrel

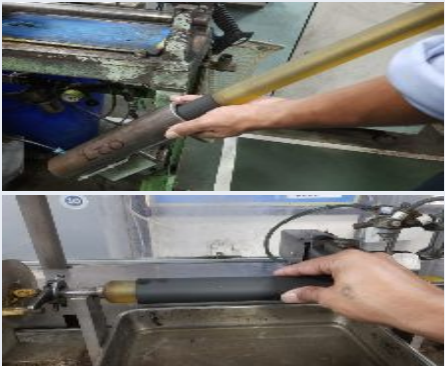
Existing mandrel is removed and tube inserted in to cutting mandrel and load on cutting machine. Tube is cut into Piston seals	In cutting process, Circular cutter is stationary and Tube with Mandrel is rotating. There is no ID cut generates in this process	Invalid
6	Washing

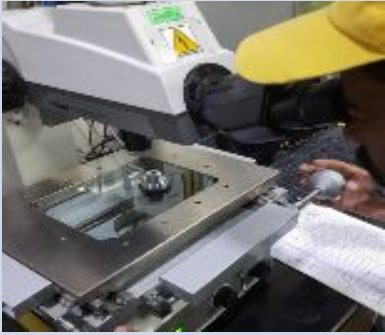
Piston Tube inspection as per Inspection standard	Inspection is done on Microscope so there is no possibility of such type of cut	Invalid
8	Appearance Inspection

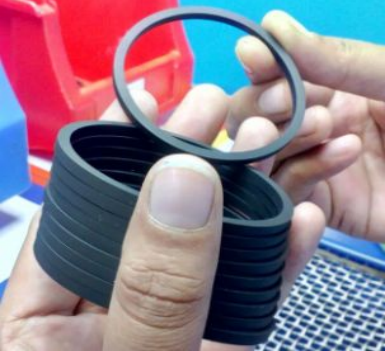
Visual Inspection verification as per Inspection Manual	Visual inspection is done without any tools or gauges so no possibility of cut	Invalid
9	Packaging & Dispatched
