# **Root Cause Analysis**

Occur / Outf.	Problem	Why-1	Why-2	Why-3	Why-4		
Occurrence	Trimming part stucked in tool ,chance of claw width over	Sometime parts get stuck up in Die after trimming and does not fly even puff of air. Operator keep running the machine continue, then core plate lug pressed by punch and claw width size become over.	There is narrow space for the trimming tool to come off when the part is stuck	No provision in tool to avoid such type issue	Claw width oversize possibility not considered as an failure mode in PFMEA during trimming		
Outflow	Checking method not sufficient to detect claw width over size on one claw at trimming & PDI	Claw width checked by vernier caliper ,during set-up, houlry & PDI, which does not ensure of whole lot /parts	Claw width oversized (One claw) possibility not considered while defined in control plan	No criteria for defining the inspection method in control plan	Procedure not available for control plan & inspection standard

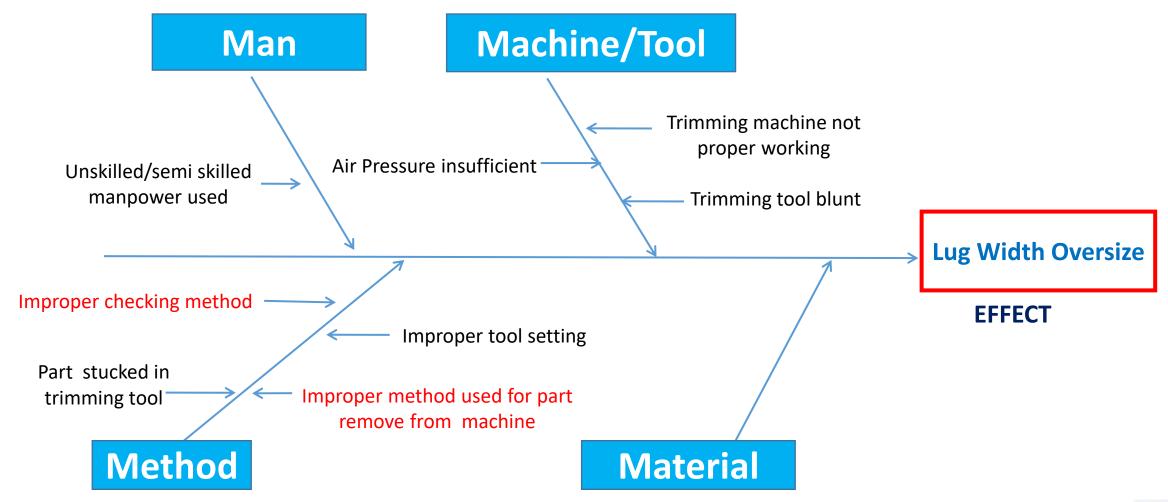
Sr. No.	Category	ory Probable Cause Verification		Jud (O/X)
1	Man	Unskilled/semi skilled manpower used	Gaurav & moti was aware about the process (WI/PRM/002, Skill matrix(F15/P&A(SKM, Limit Sample	o
2		Insufficient air pressure	Observed pressure was 4 kg/cm2 found ok (WI/PRM/002)	O
3	Machine/Tool	chine/Tool Trimming machine not working properly  As per machine check sheet found ok		0
4		Trimming tool blunt	Checked reshaping frequency proper adhered found ok	o
5		Improper checking method	At trimming process Part checked by vernier caliper during set-up & in-process inspection , but Possibility is there to bypass . F31/QAD(HIR-TRIM)	x
6	Method	Part Stucked in trimming tool	Observed part no chance of stucking in tool(WI/PRM/002)	O
7		Improper tool setting	Observed setting done properly by tool setter(WI/PRM/002) F31/QAD(HIR-TRIM)	o
8		Improper method used for part remove from machine	When parts are stored at near trimming tool, a part gets stuck in the tool, so that when trimming another part with same condition, the width of the claw increases over of stuck part.	x
