Casting Crack Issue of KOLA

- **Phenomenon:** Casting Crack

- **Model-** KOLA drum LH
- **Parts name-** Outer Tube
- **Qty NG-** 118 No Each

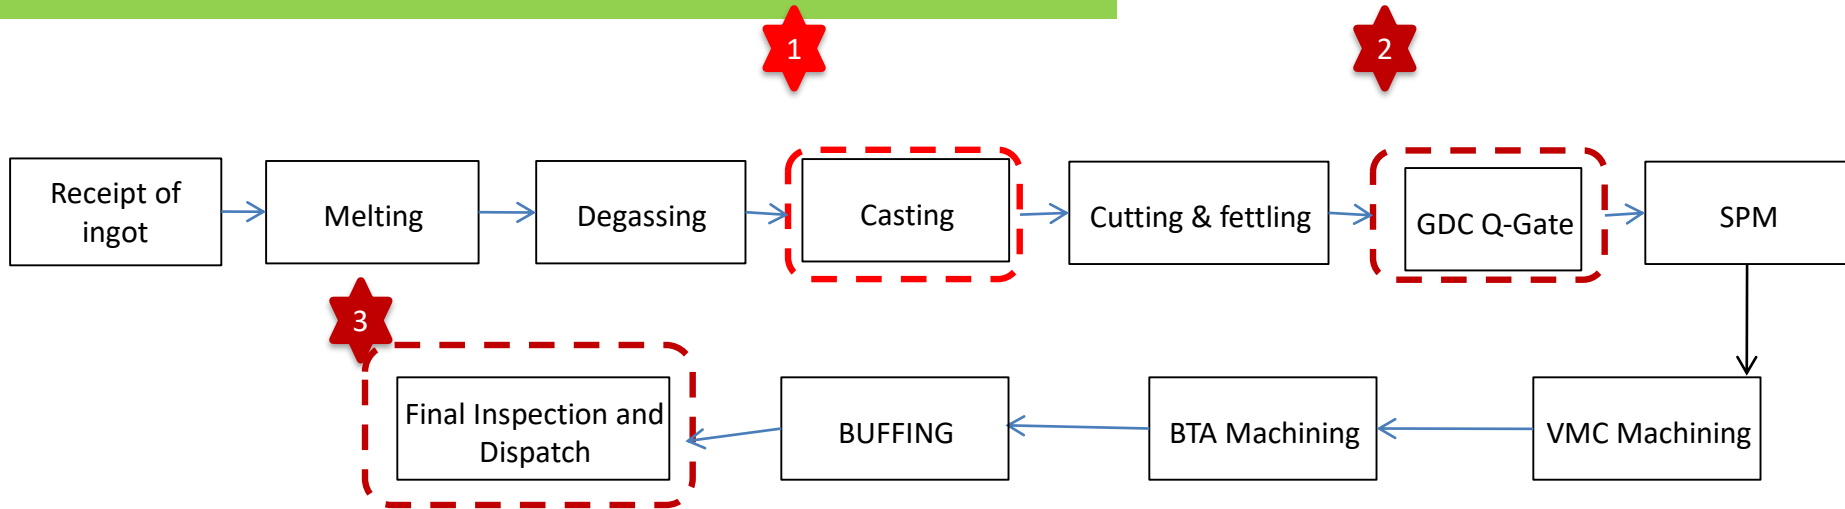
KOLA Outer Tube Process Flow

Possible defect occurrence area.

Possible defect detection area.

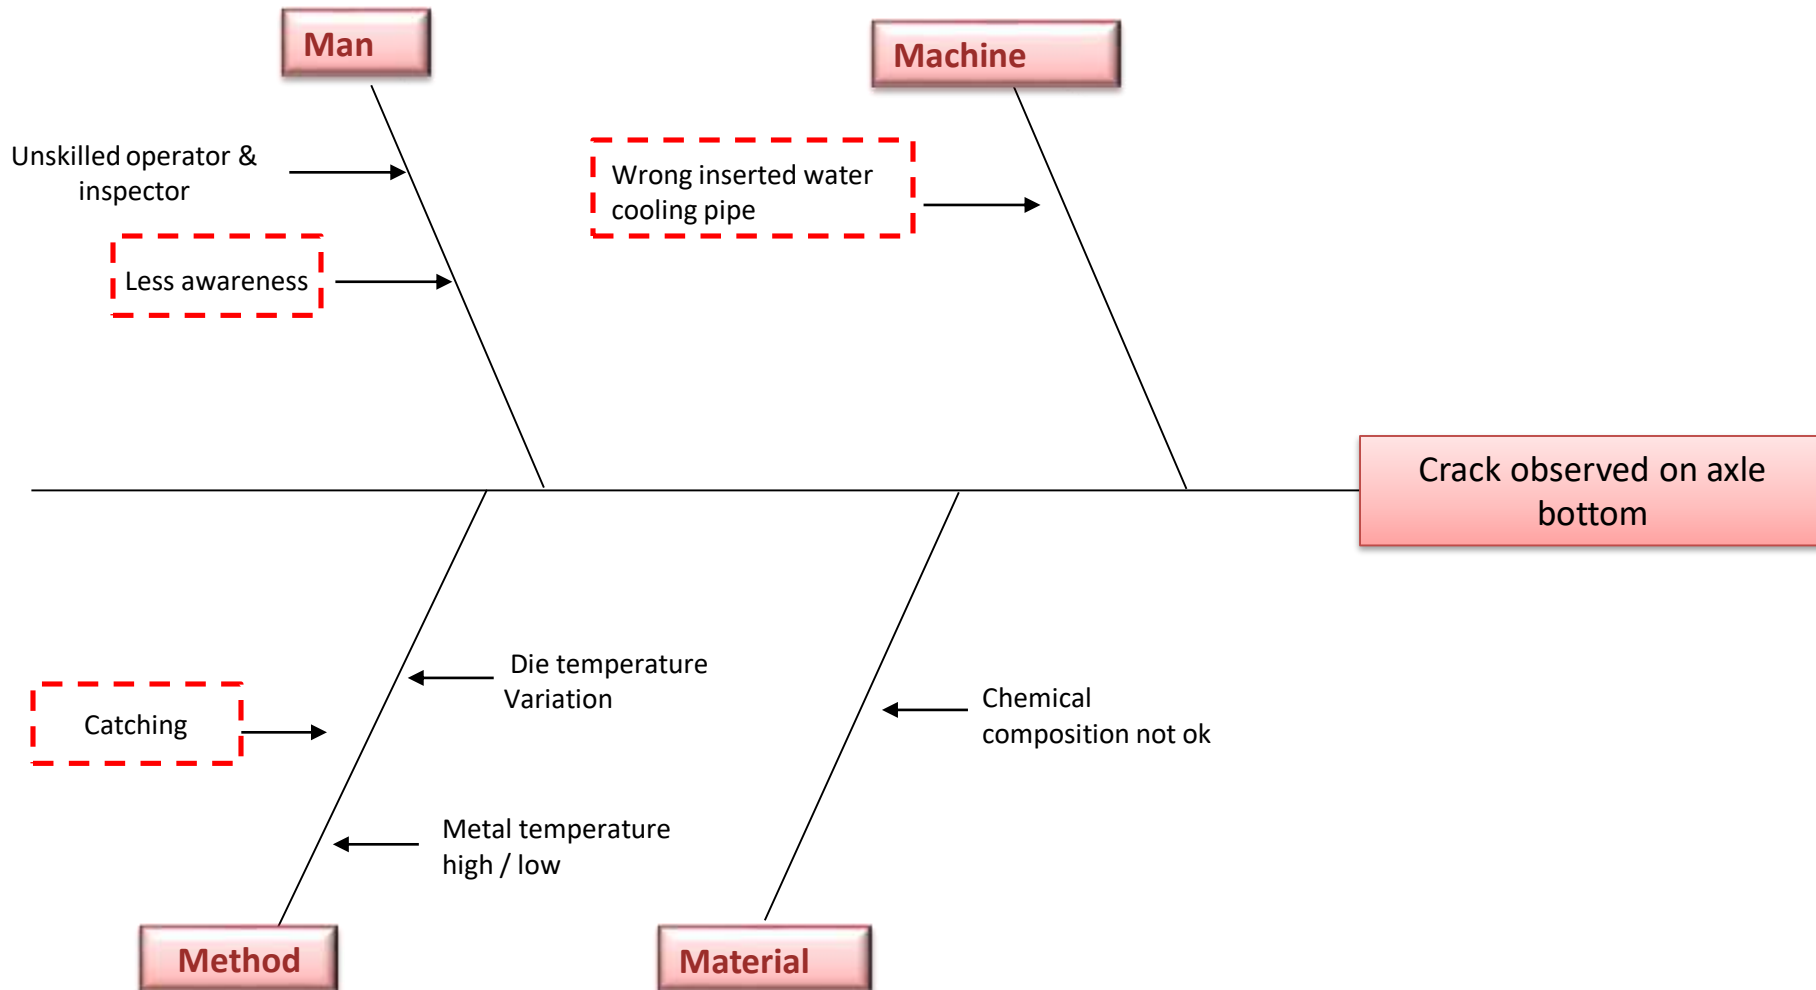
• Understanding the actual cause – (Factor analysis)

- **Conclusion:** The operator incorrectly placed the chilling pipe in the centre of the die, so the bottom side of the part did not cool properly, resulting in a crack.

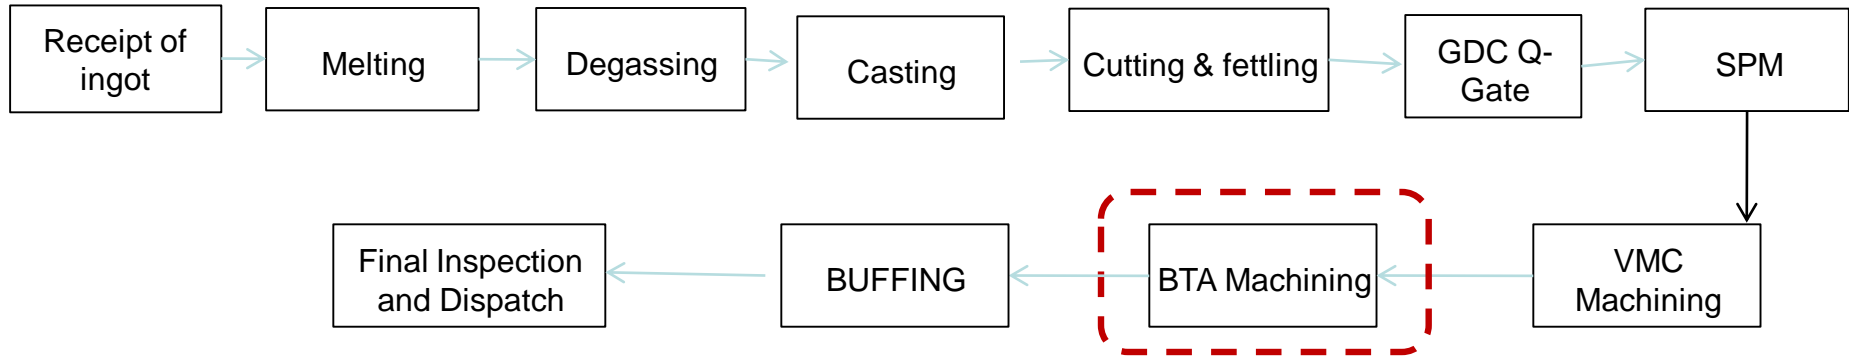
KOLA Outer Tube Process Flow

Possible defect occurrence area.

Possible defect detection area.

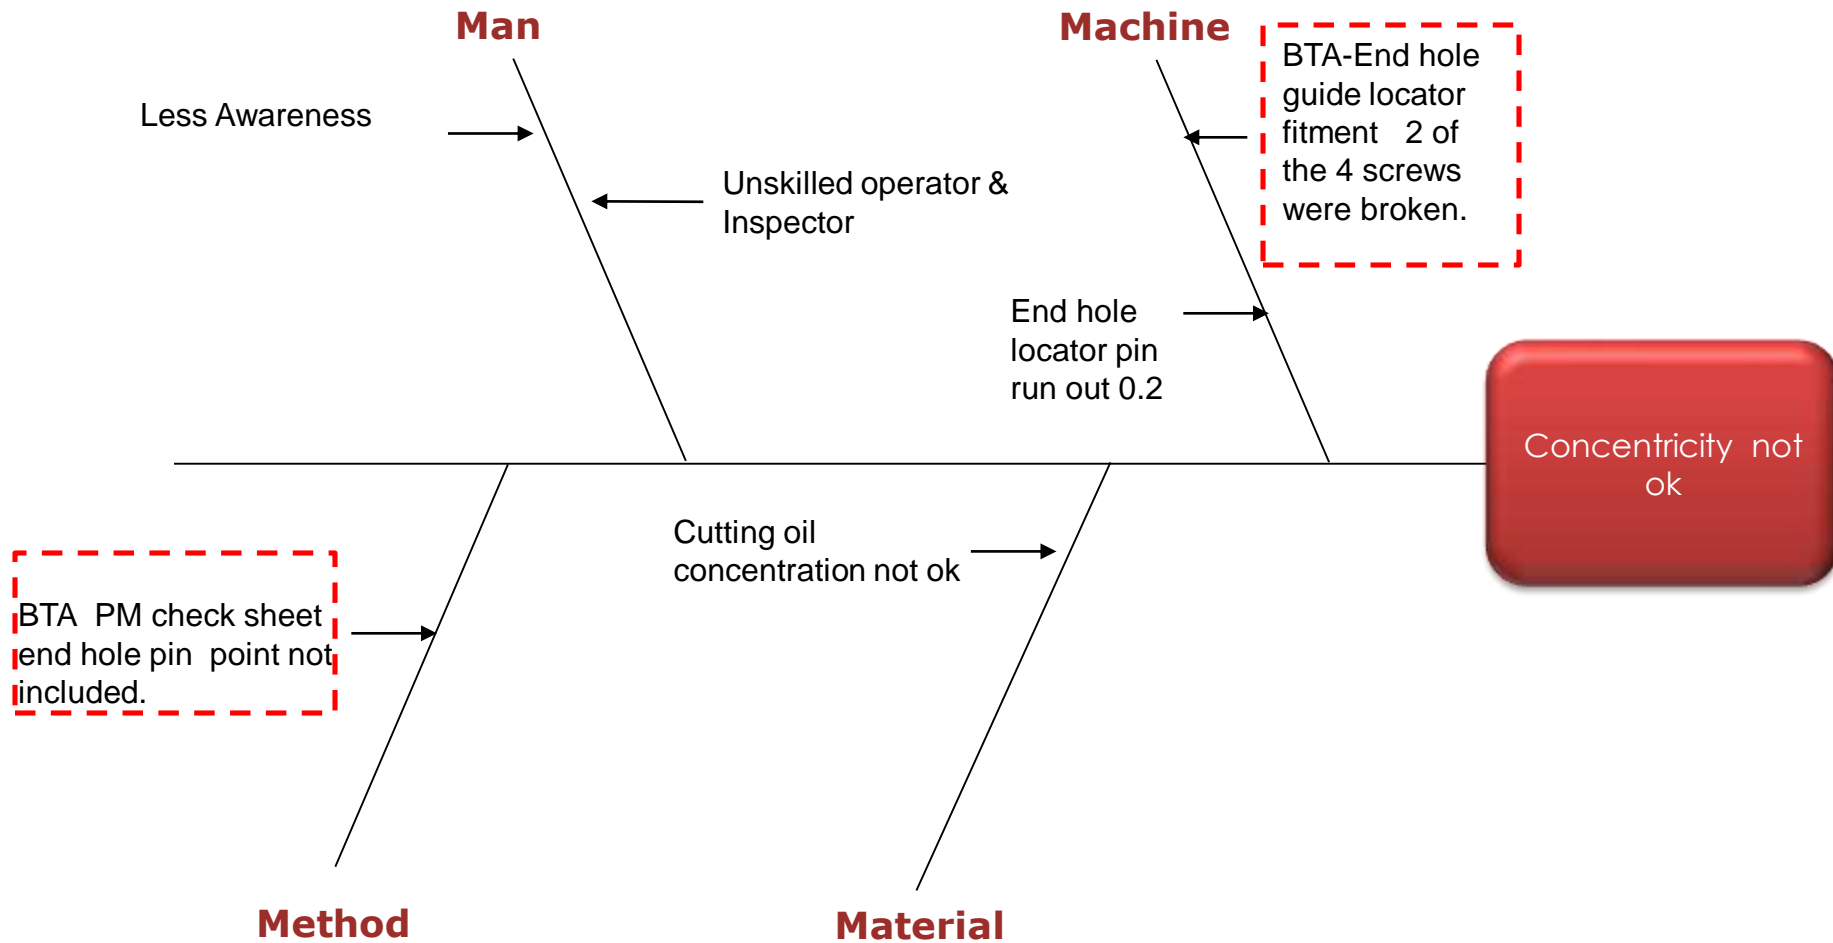
• Understanding the actual cause – (Factor analysis)

WHY-1	WHY-2	WHY-3	WHY-4
Occurrence Side	Concentricity found up to 0.3	BTA-End hole guide locator fitment 2 of the 4 screws were broken.	End hole guide pin lock not properly.	guide pin run out increase up to 0.2
Detection side	In process inspection checking frequency in 2 part in one shift.	Unskilled operator & Inspector
