Improvement Area: Core Plate Packing

Improvement Theme: To improve core plate packing to avoid Flatness ,Broken & Damage issue during transit

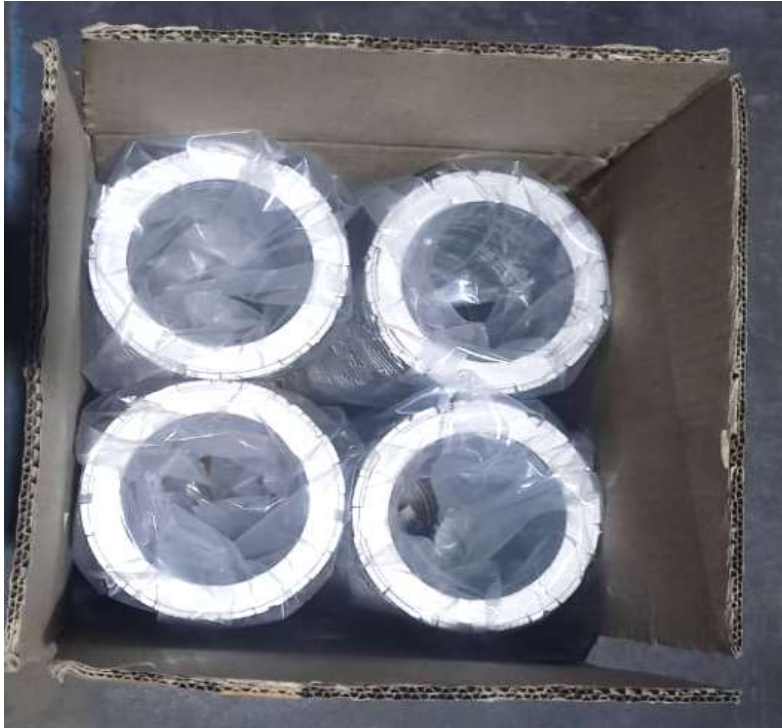
BEFORE

Status: 5 ply corrugated box using for core plate packing ,No separator available at bottom & top side ,Change of damage & flatness out issue .

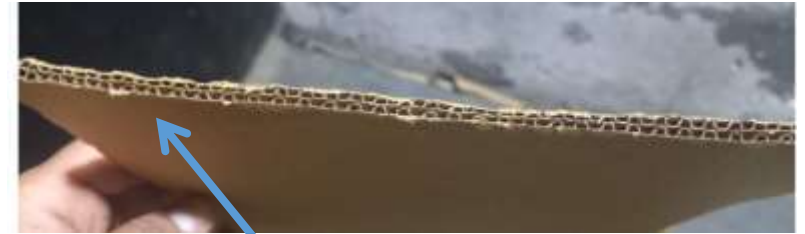
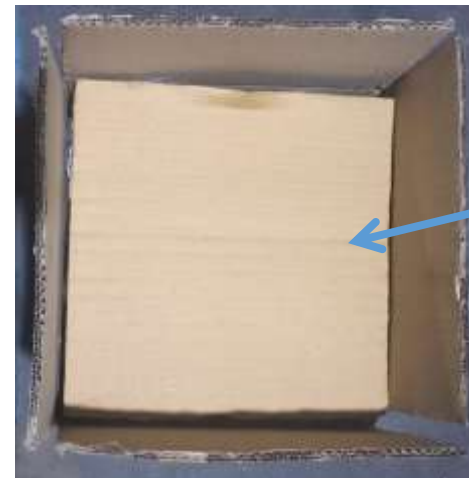
AFTER

5 Ply corrugated sheet

Status: 5 ply extra corrugated sheet provided in box at bottom & top side to avoid Flatness , broken & damage issue in core plate of K70 and as well as in other core plate

Benefits: Claw broken & Damage issue eliminate during transit
