ANANT ENTERPRISES

Defect: Pin Hole /Blow Hole

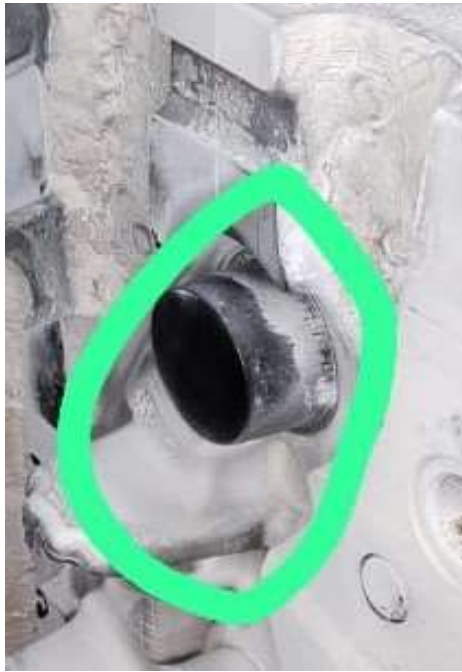
Before

Die Coating Peel of due to touch up time more than 3hrs

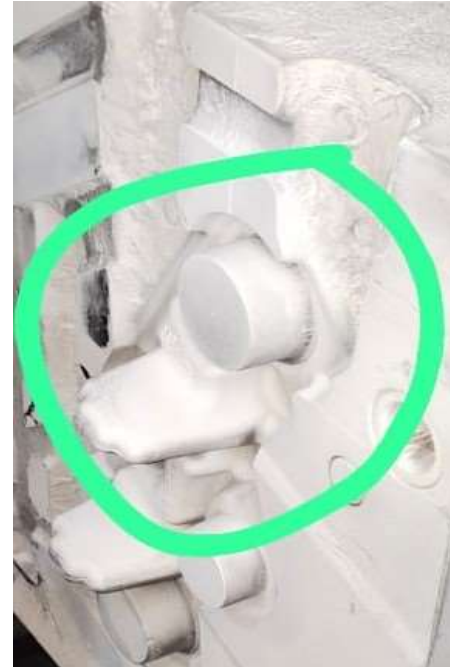
After

Die touch up within 1-2hrs
