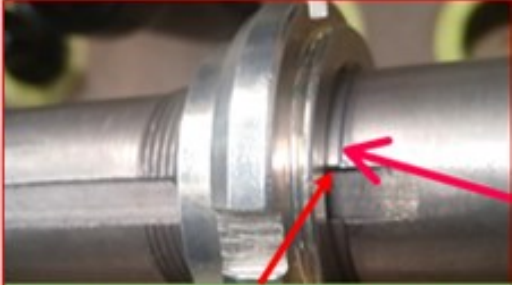
**BEFORE**

Gap observed after tightening of matting part or Matting part not answering till groove end

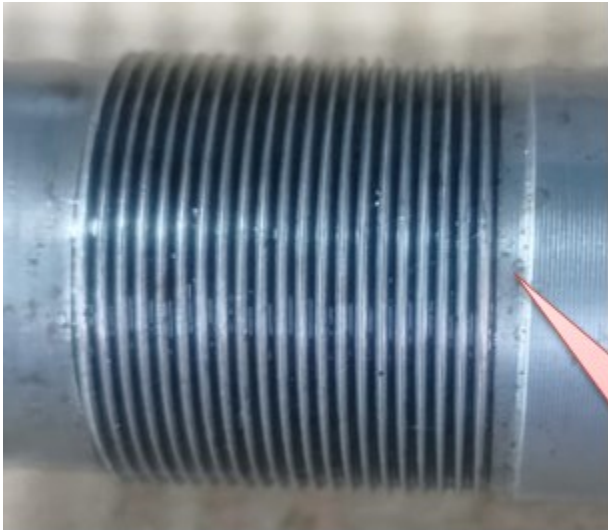
No thread minor diameter mark in groove

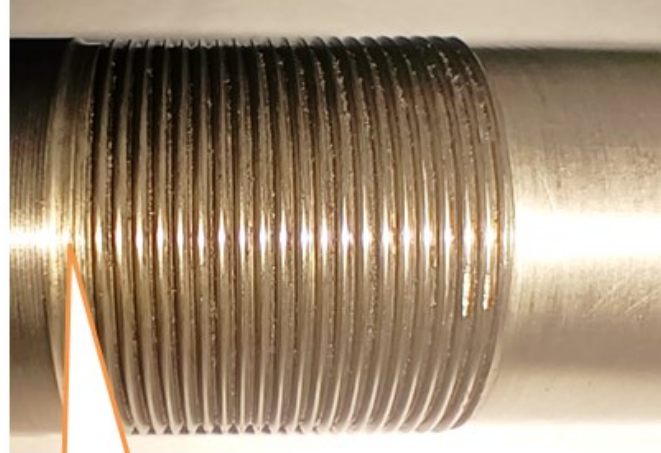
**AFTER**

Thread minor diameter mark in the groove to answer the gauge till last

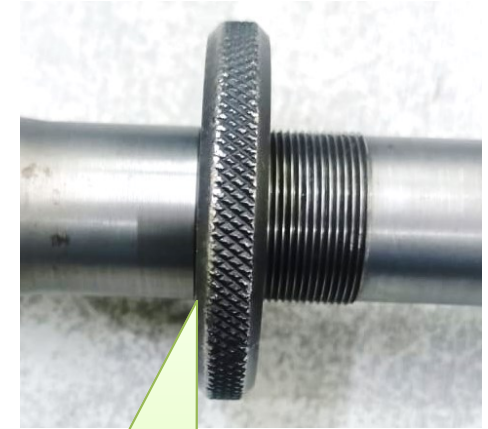
NO Gap ,gauge answering till groove end.
