Theme

Visual Inspection of Bush Oil slot and Part Miling slot should be Matched.

Present Problem :-

MISSMATCH-BUSH OILE SLOT POSITION SHIFT

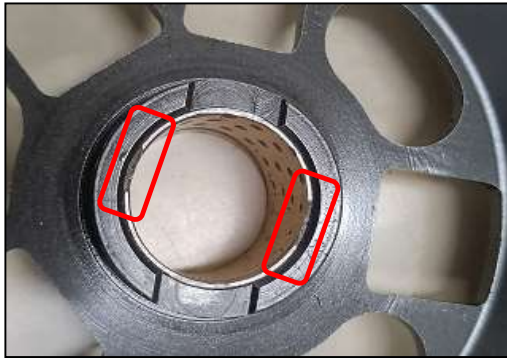
NOT OK PART

1) Bush Milling (oil groove) slot and GPDN Milling (oil groove) slot should be matched (Bush groove slot should be in center of GPDN milling (oil groove) slot.

2)Visual Inspection of Bush Oil slot and GPDN . Miling slot should be confirm with match inline.

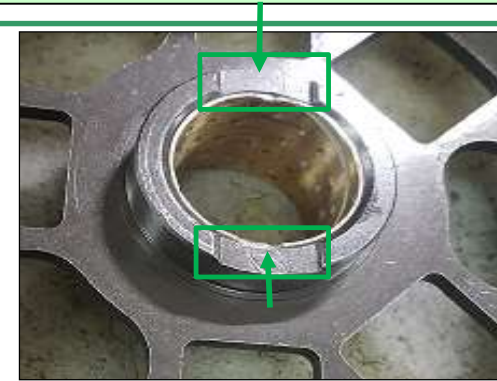
OK PART
